RESTORE REPORTS DOCUMENTATION

SKETCH/AREA TABLE ADDENDUM

*** INTRUSION FAILURES PLAGUE THIS PROPERTY - STRUCTURE HAS THESE AREAS NEED IMMEDIATE ATTENTION ALLOWING COMMON STRUCTURE CONTAINMENT SAVING INTERIOR COMPONENTS (A/C - APPLIANCES - PREVENTING MOLD GROWTH)***

POST INSPECTION CONCLUSION

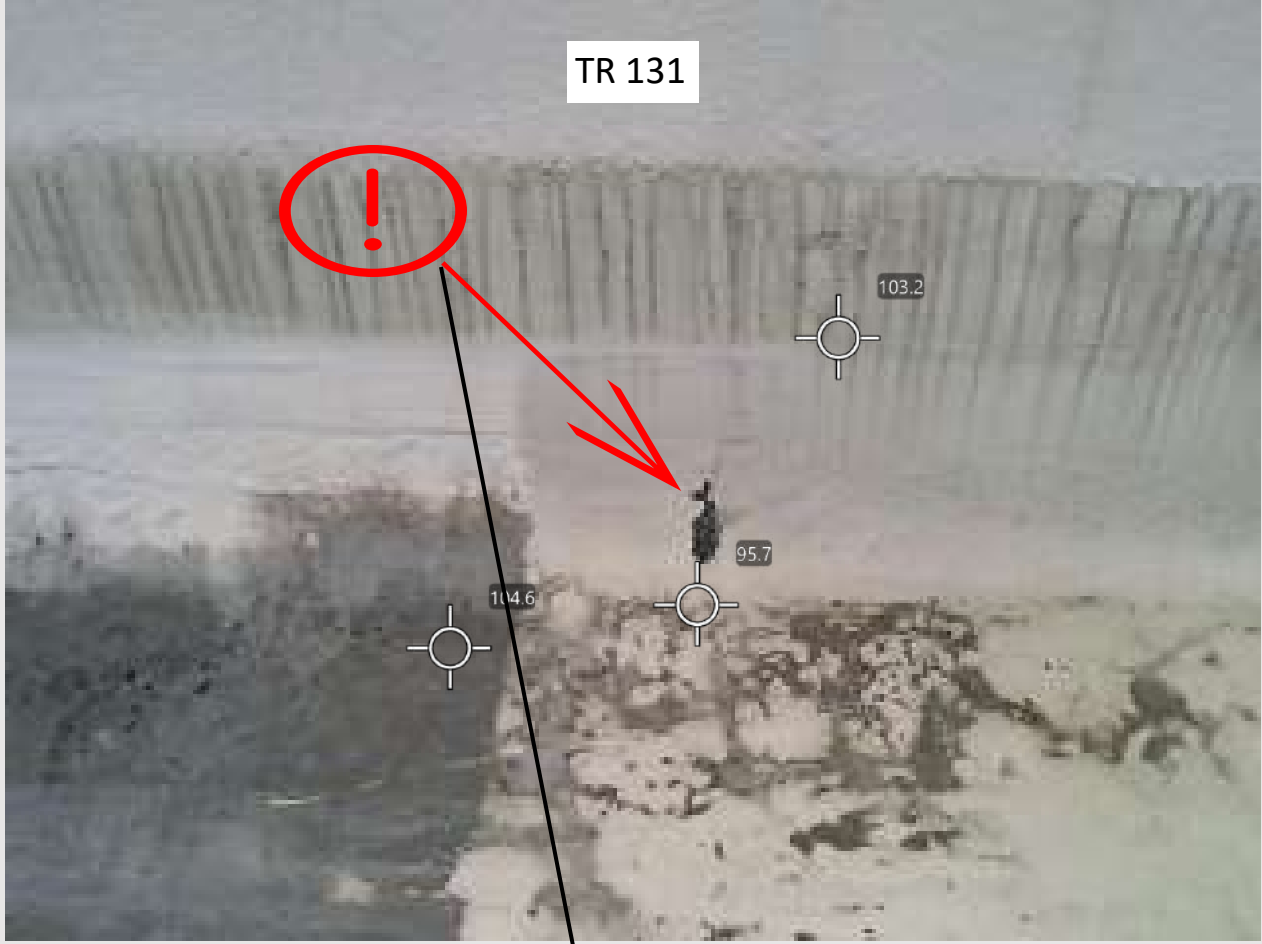
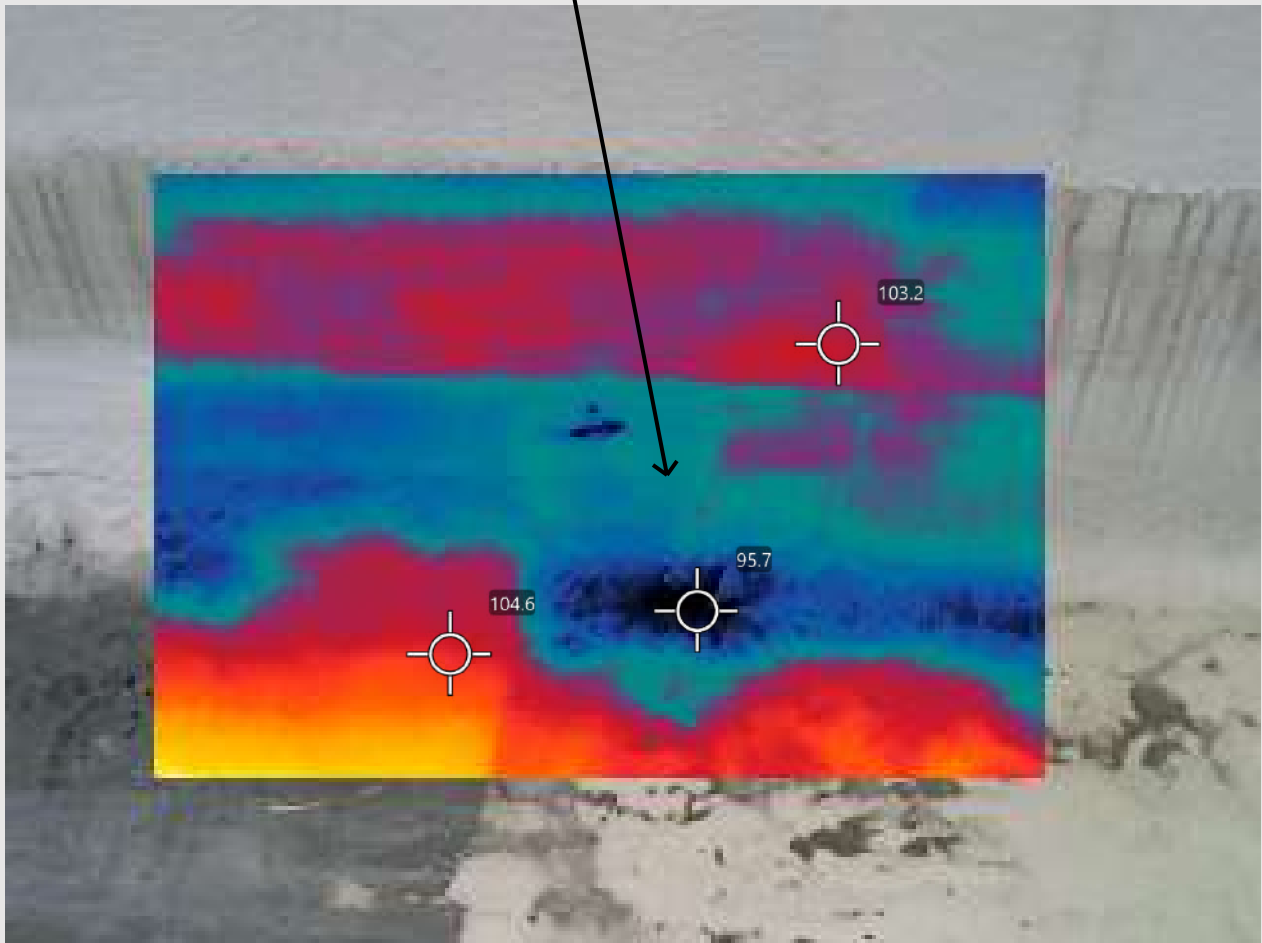
TR 131

CAP TERMINATION FAILURE ALLOWING SEPERATION. SATURATION INDICATED BENEATH MEMBRANE

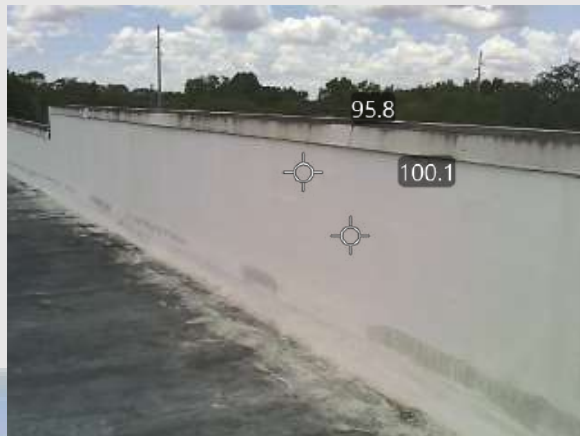
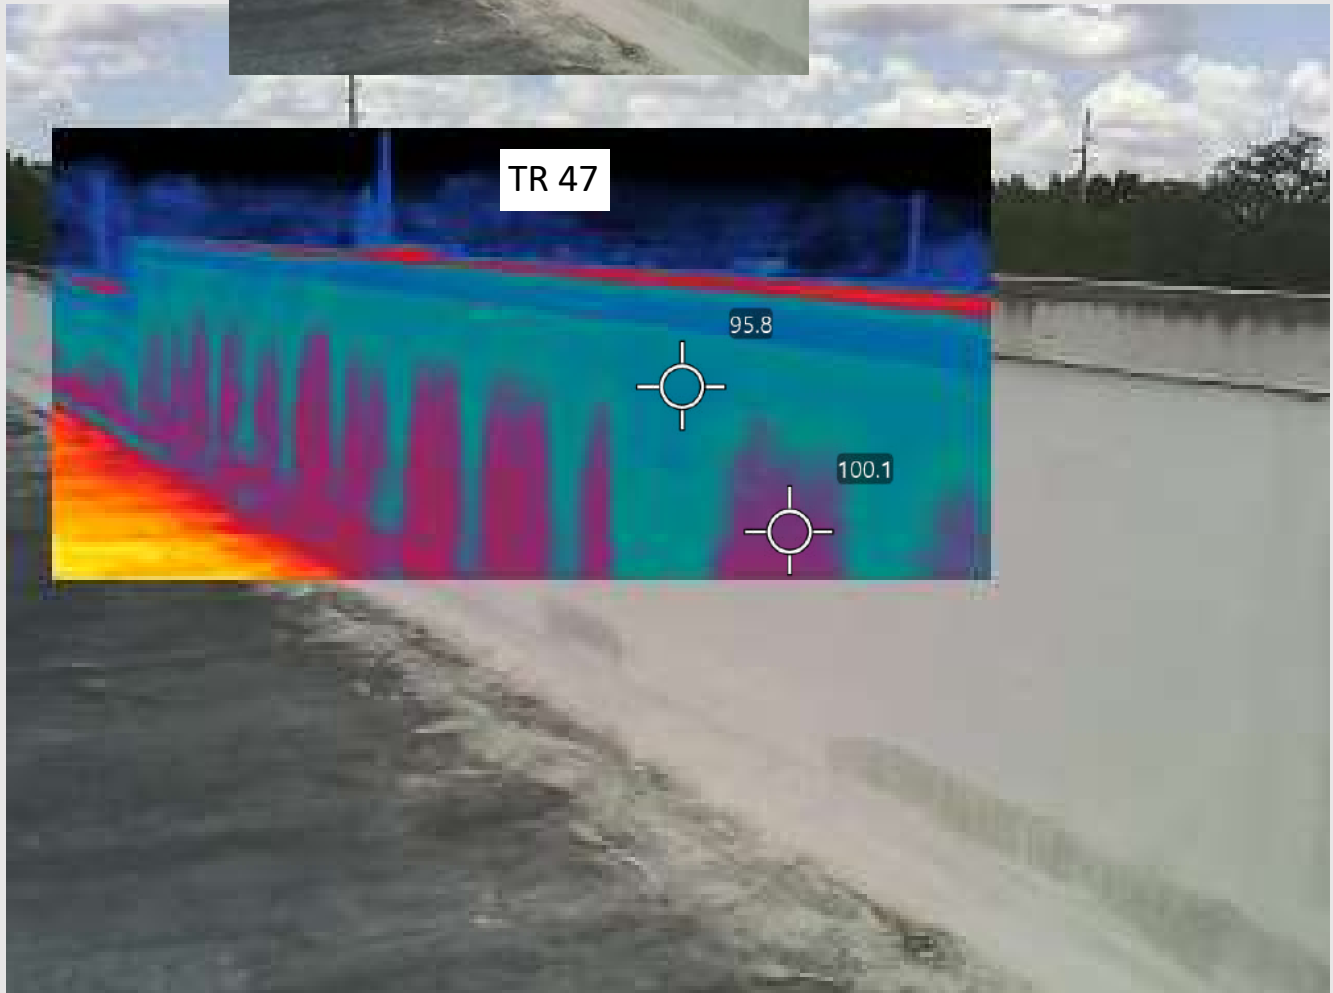
**MEMBRANE ATTACHMENT IMAGING DOCUMENTING MATERIAL
TERMINATION FAILURE DRIVING DISCHARGE DIRECTLY UNDER TPO CREATING
RUN THROUGH SEPERATING ADHESIVES AND MATERIAL CAUSING MATERIALS
RELEASE AND BLOATED MEMBRANE**

**THROUGHOUT ROOF SURFACE REPAIR TECHNIQUE EXPOSED SUB SURFACE
MATERIAL TO MOISTURE. THIS DANGEROUS SITUATION ADDS THOUSANDS
OF POUNDS FROM MATERIAL SATURATION CHANGING WEIGHT
DISTRIBUTION**

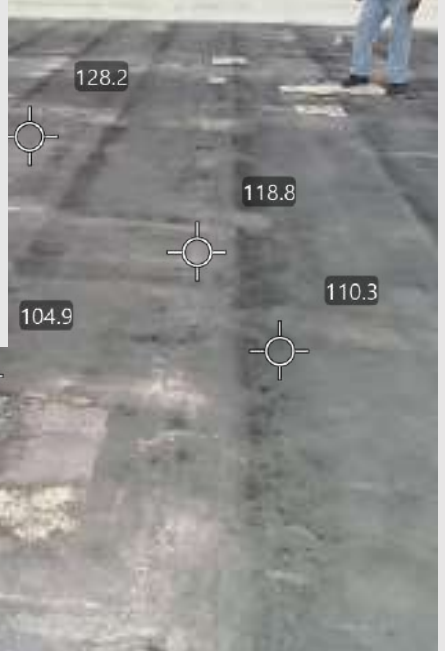
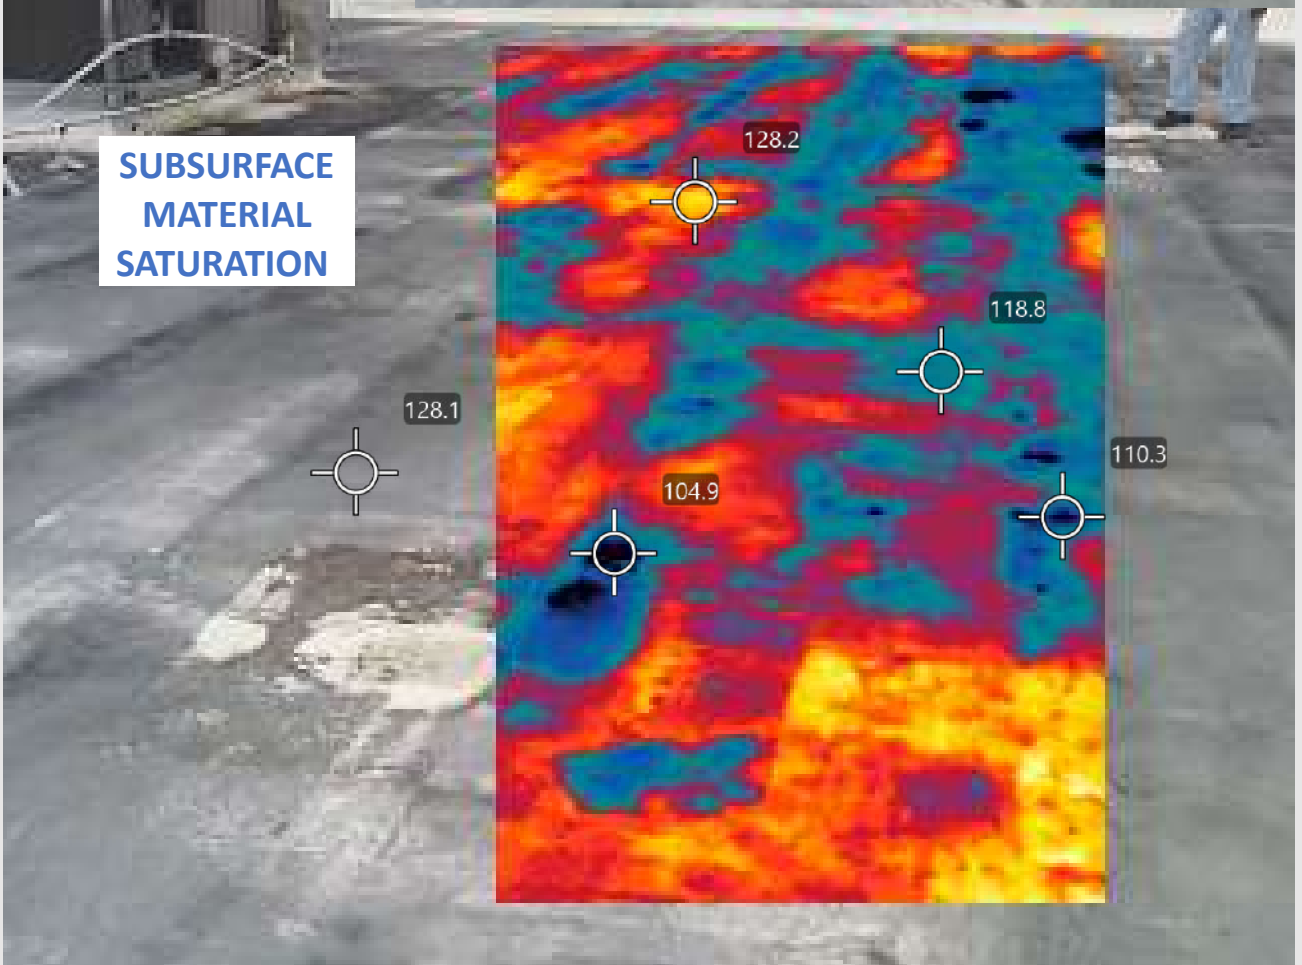
MEMBRANE ATTACHMENT IMAGING DOCUMENTING MATERIAL TERMINATION FAILURE DRIVING DISCHARGE DIRECTLY UNDER TPO CREATING RUN THROUGH SEPERATING ADHESIVES AND MATERIAL CAUSING MATERIALS RELEASE AND BLOATED MEMBRANE

THROUGHOUT ROOF SURFACE REPAIR TECHNIQUE EXPOSED SUBSURFACE MATERIAL TO MOISTURE. THIS DANGEROUS SITUATION ADDS THOUSANDS OF POUNDS FROM MATERIAL SATURATION CHANGING WEIGHT DISTRIBUTION

EXAMPLE SUBSURFACE SATURATION PENETRATING THE MEMBRANE

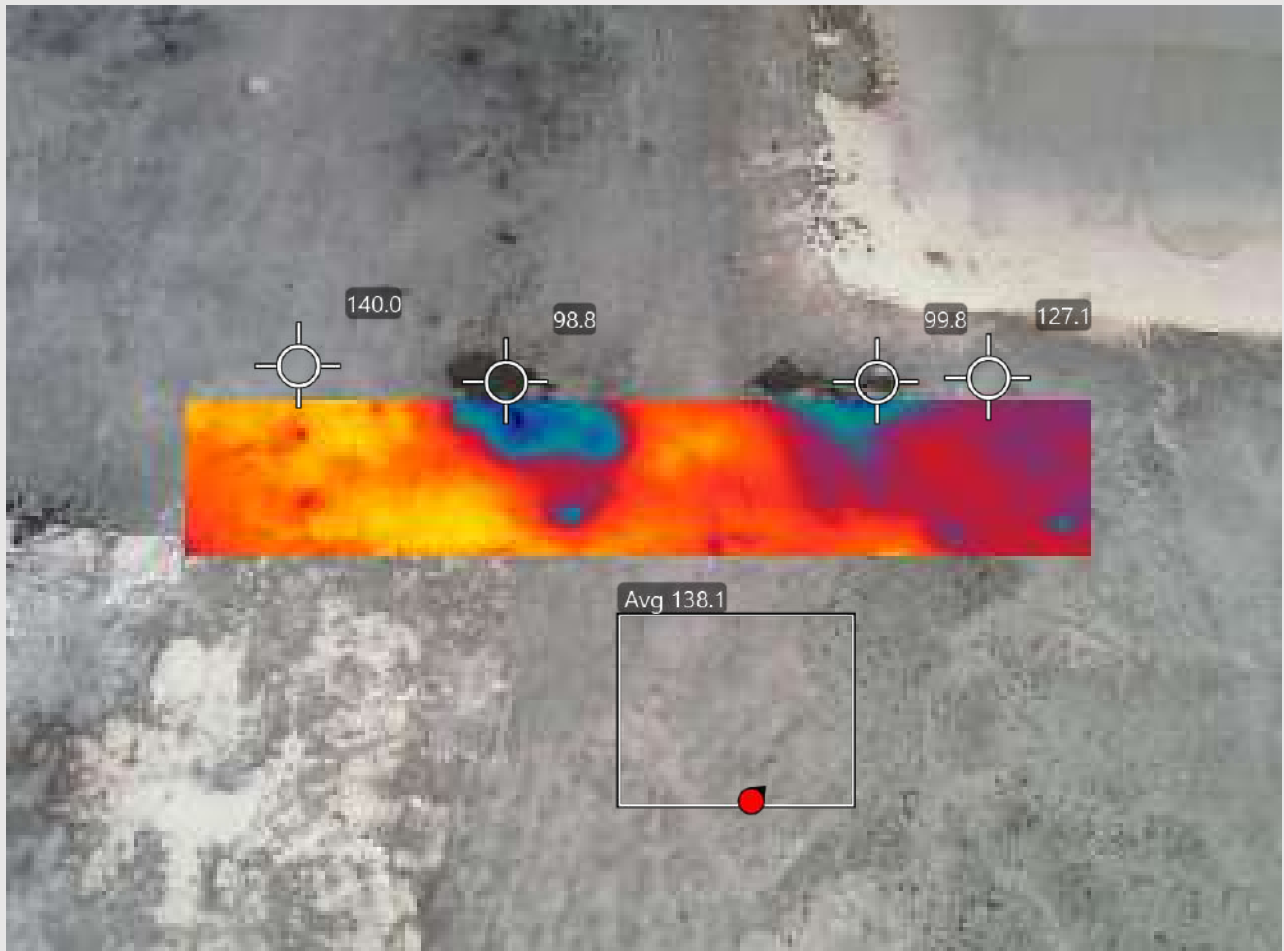
A/C SERIES IMAGING DOCUMENTING A/C FAILURE DRIVING DISCHARGE DIRECTLY UNDER TPO CREATING RUN THROUGH SEPERATING ADHESIVES AND MATERIAL CAUSING MATERIALS RELEASE AND BLOATED MEMBRANE

THROUGHOUT ROOF SURFACE REPAIR TECHNIQUE EXPOSED SUBSURFACE MATERIAL TO MOISTURE. THIS DANGEROUS SITUATION ADDS THOUSANDS OF POUNDS FROM MATERIAL SATURATION CHANGING WEIGHT DISTRIBUTION

IF ONLY HAVE OF SUBROOFING MATERIALS BECOME SATURATED THIS CAUSE STRESS TO MATERIALS POSSIBLY CAUSING COMPONENT FAULURE - CATOSROPHIC CONDITIONS DUE TO WEIGHT STRUCTURE IS NOT DESIGNED TO MAINTAIN

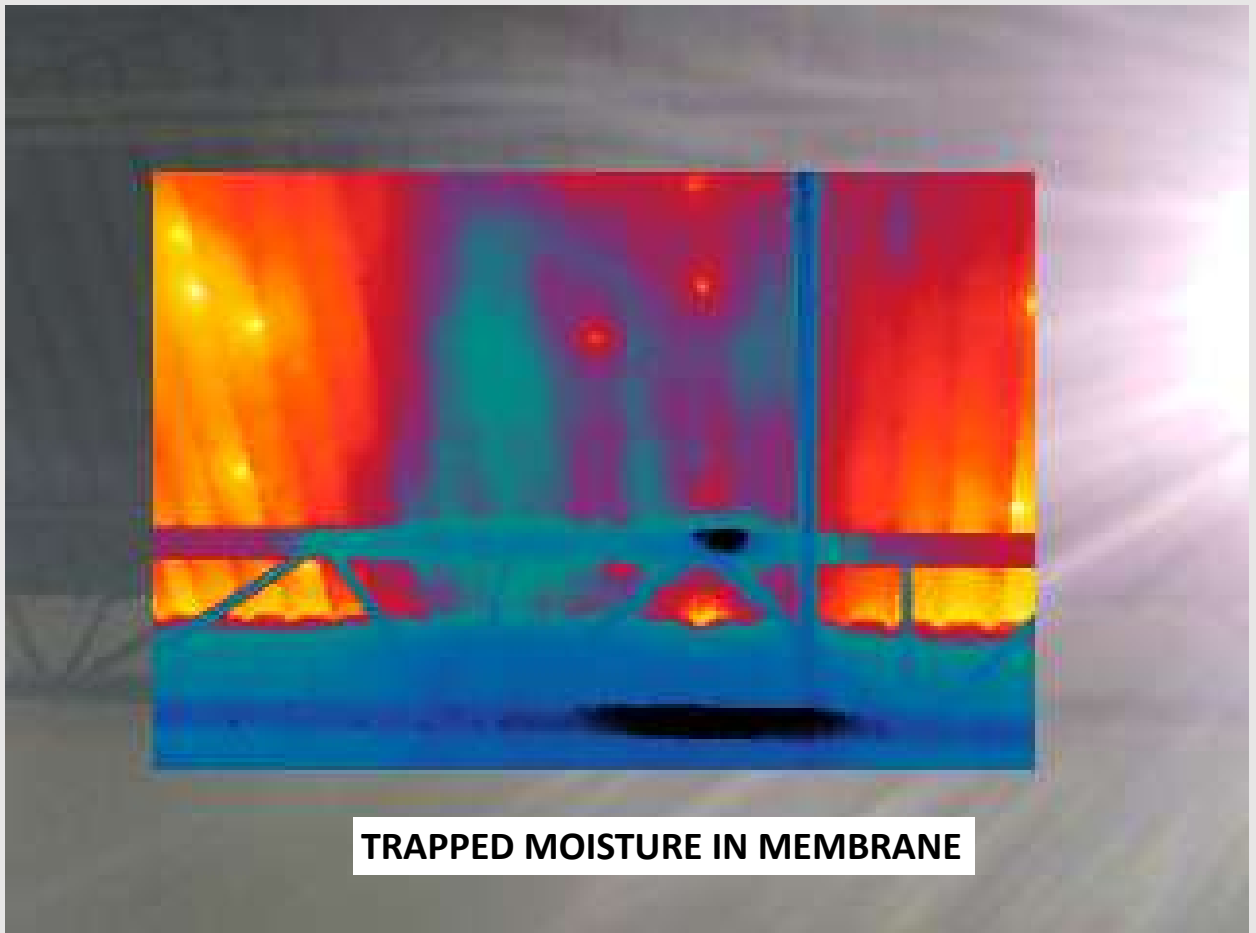
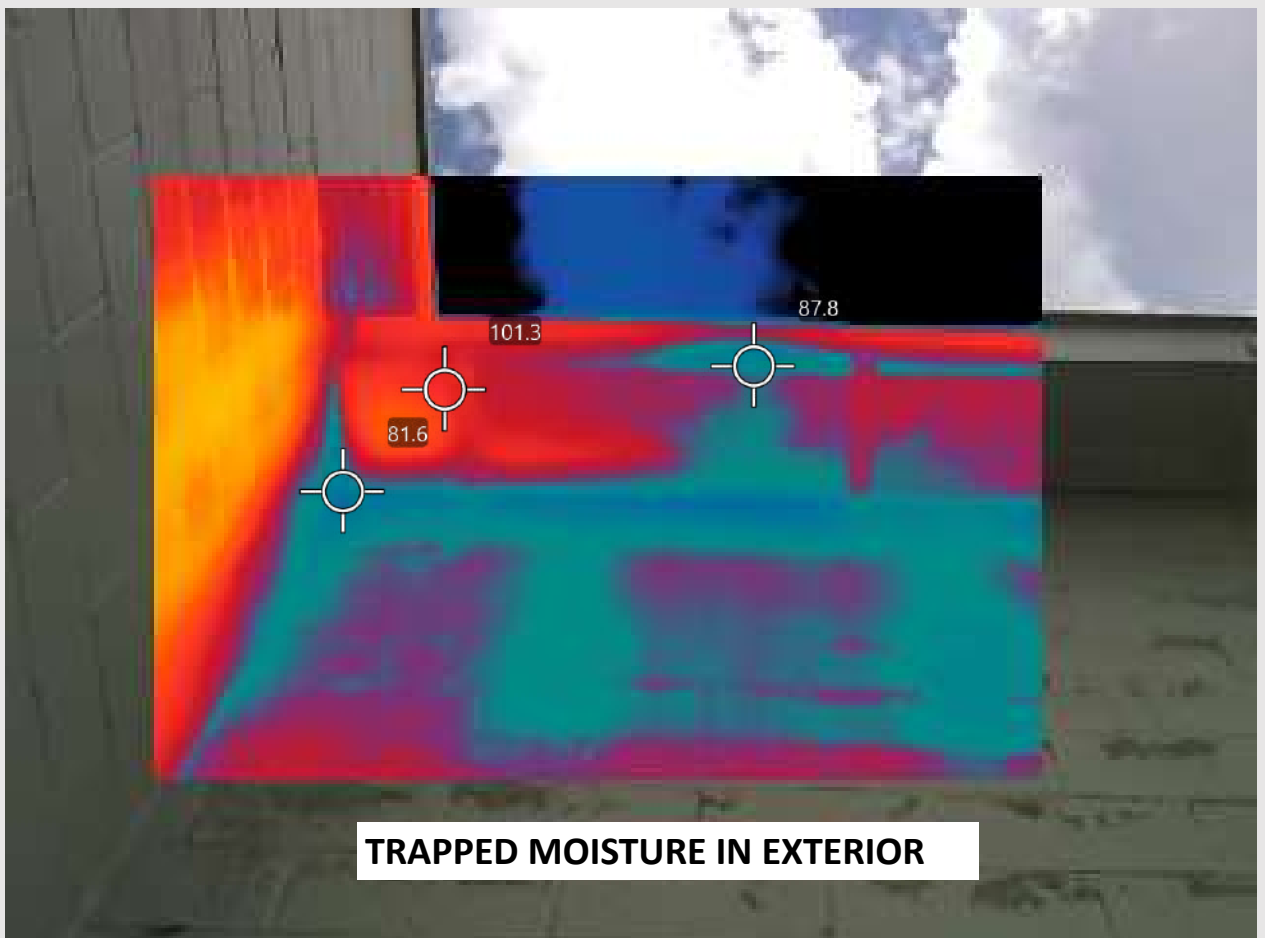
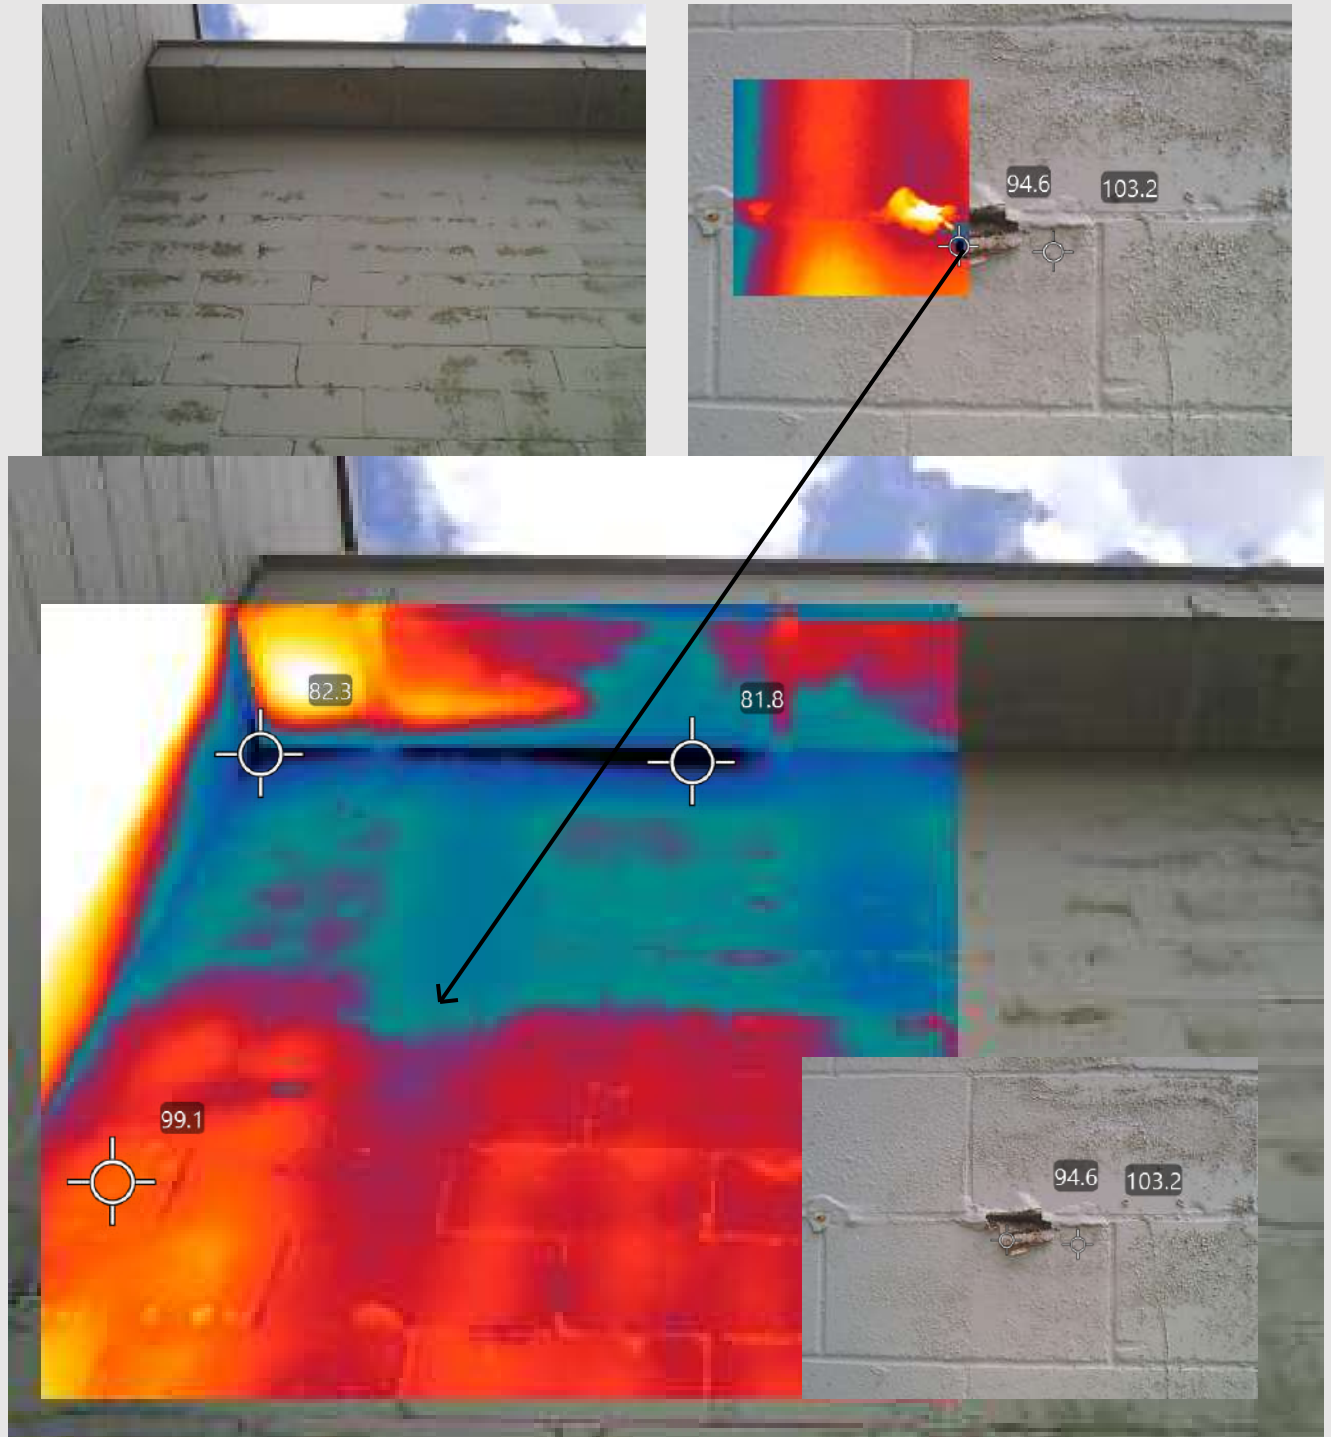
EXTENDED SATURATION OF ROOFING MATERIAL(S) WEAKENS COMPONENTS AND MATERIALS PROPERTIES ACCELERATING DETERIORATION. SPALLING IS CAUSED BY LONGTERM SATURATION OF REBAR INBEDDED IN CEMENT CREATING STRUCTURAL INTERGRITY. SPALLING REBAR WILL RUST AWAY LEAVING DANGEROUS POCKETS CREATING COMPOUND COMPRESSION FAILURE LOSS

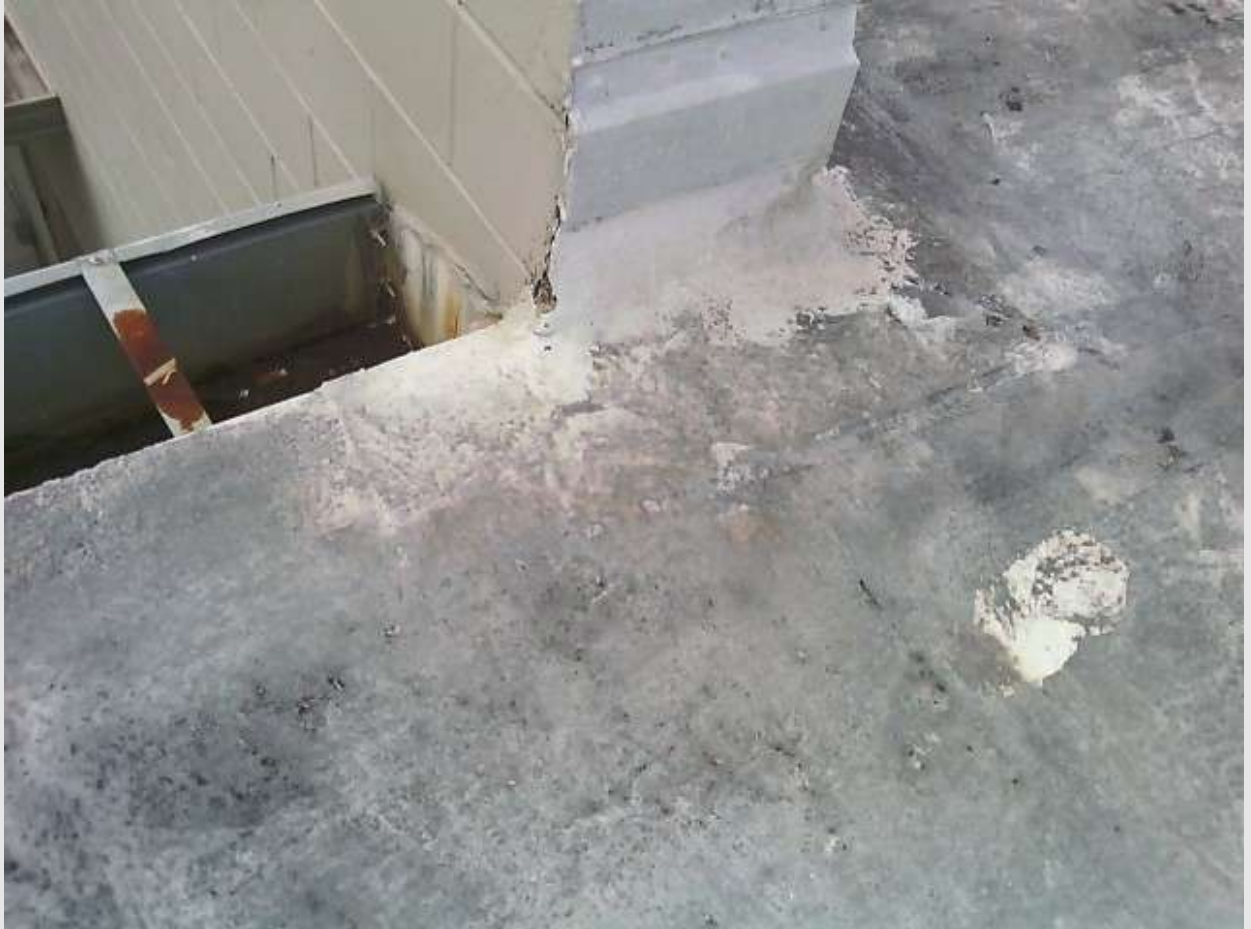
EXAMPLE OF EDGE FAILURE - LOSS

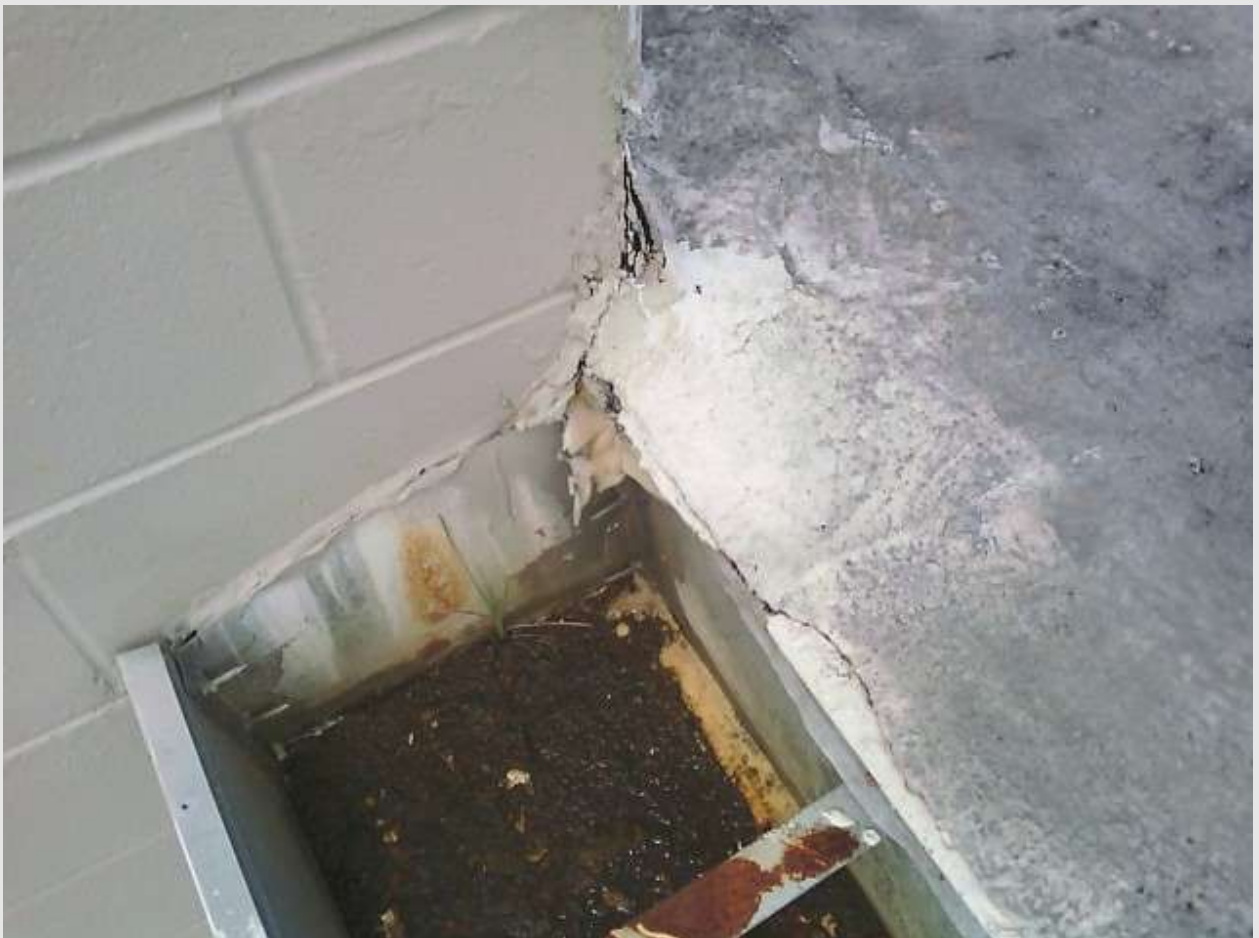
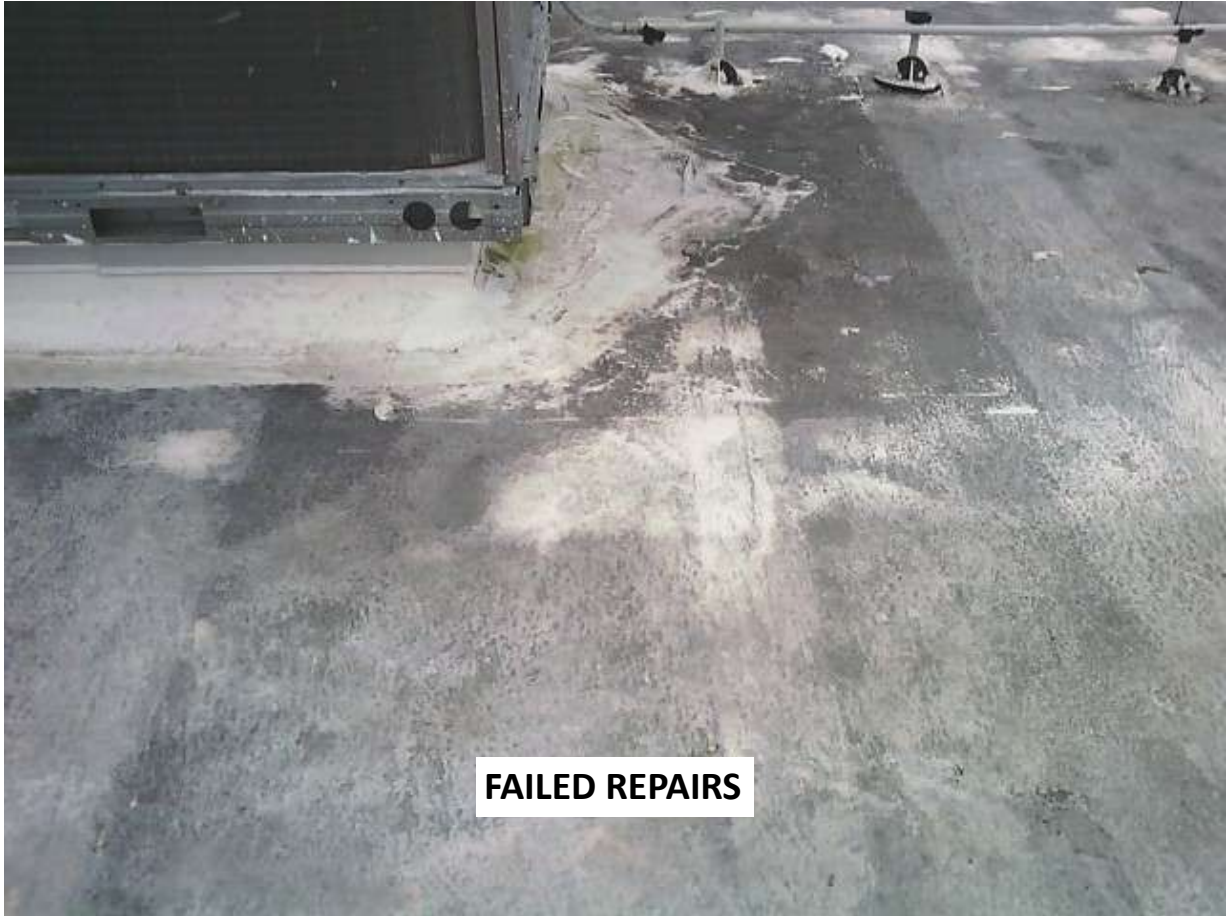
FAILED REPAIRS

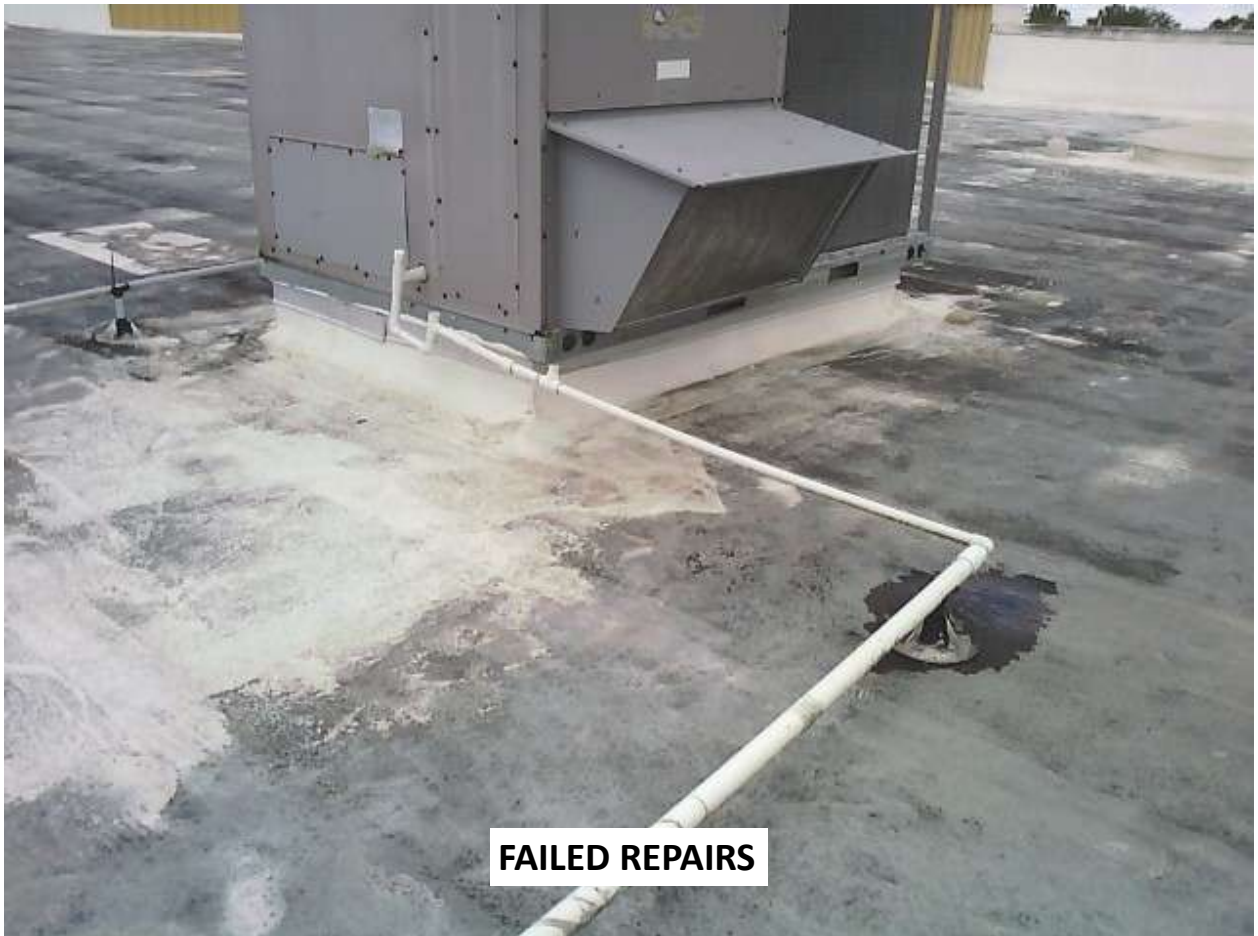
FAILED REPAIRS

ORIGINAL METAL CAP FLASHING SHOWS STRESS FAILURE (CRACKING) AND SEAM FAILURE ALLOWING RAIN WATER TO PENETRATE BENEATH TPO MEMBRANE CREATING EXTERNAL BLISTERING OF MATERIAL. ONCE BENEATH MEMBRANE SATURATION OF MATERIALS AND LEAKING OCCUR. REVIEW OF ISSUED PERMITS DOESNT INCLUDE ROOF REPAIR OR REPLACEMENT.

THIS WOULD LEAD US TO BELIEVE THE MATERIALS IN INSPECTED ARE ORIGINAL TO BUILD (1998) MAKING THE ROOF 25 YRS OLD . ALL MATERIALS INCLUDED IN ROOF SYSTEM HAVE EXCEEDED MANUFACTURES' LISTED LIFE EXPECTANCY

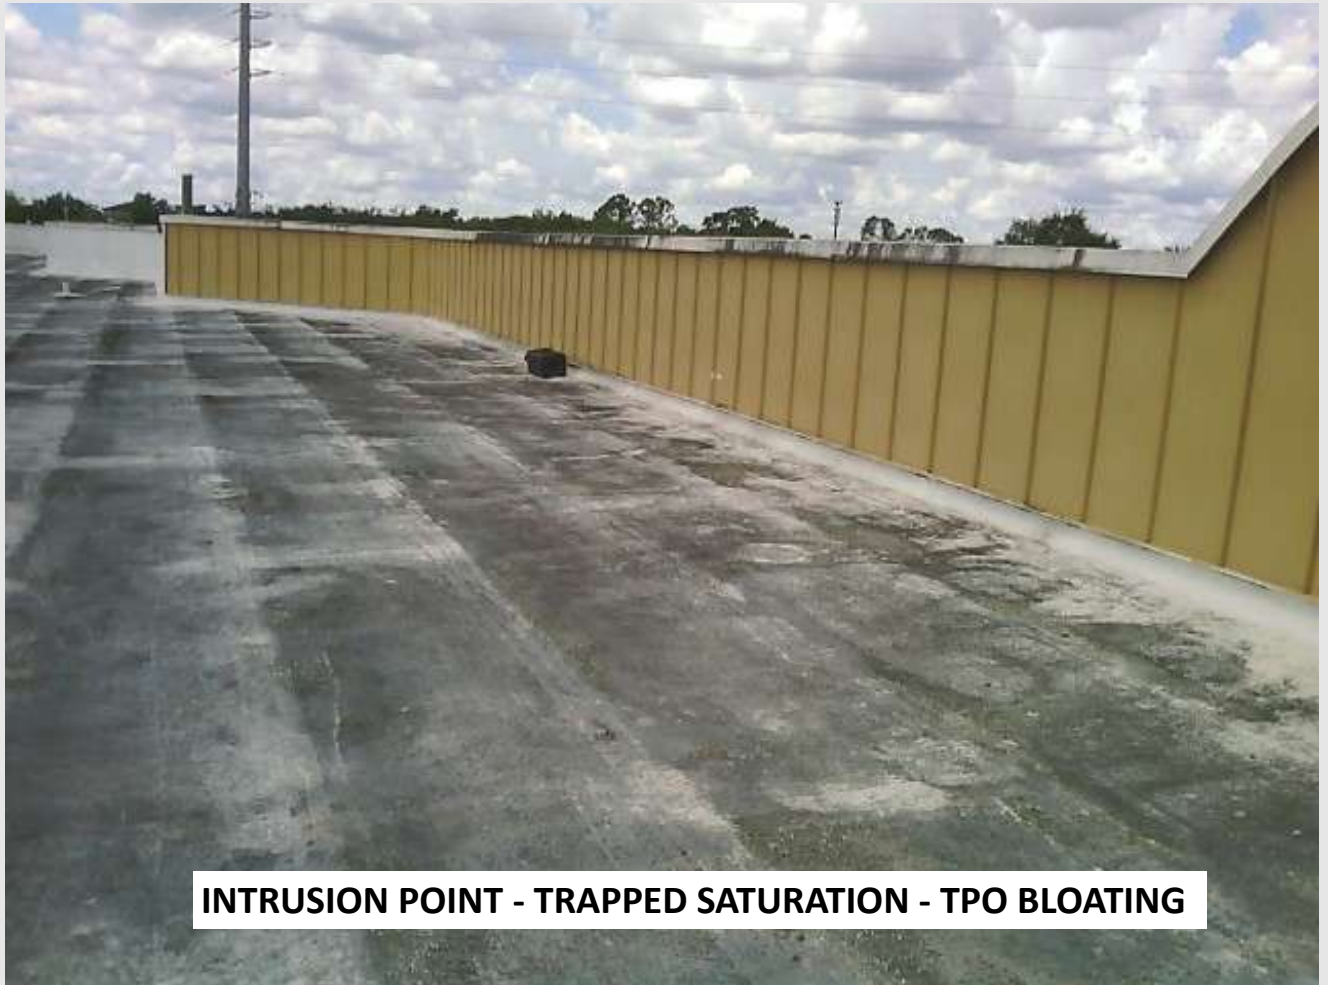
INTRUSION POINT - TRAPPED SATURATION - TPO BLOATING

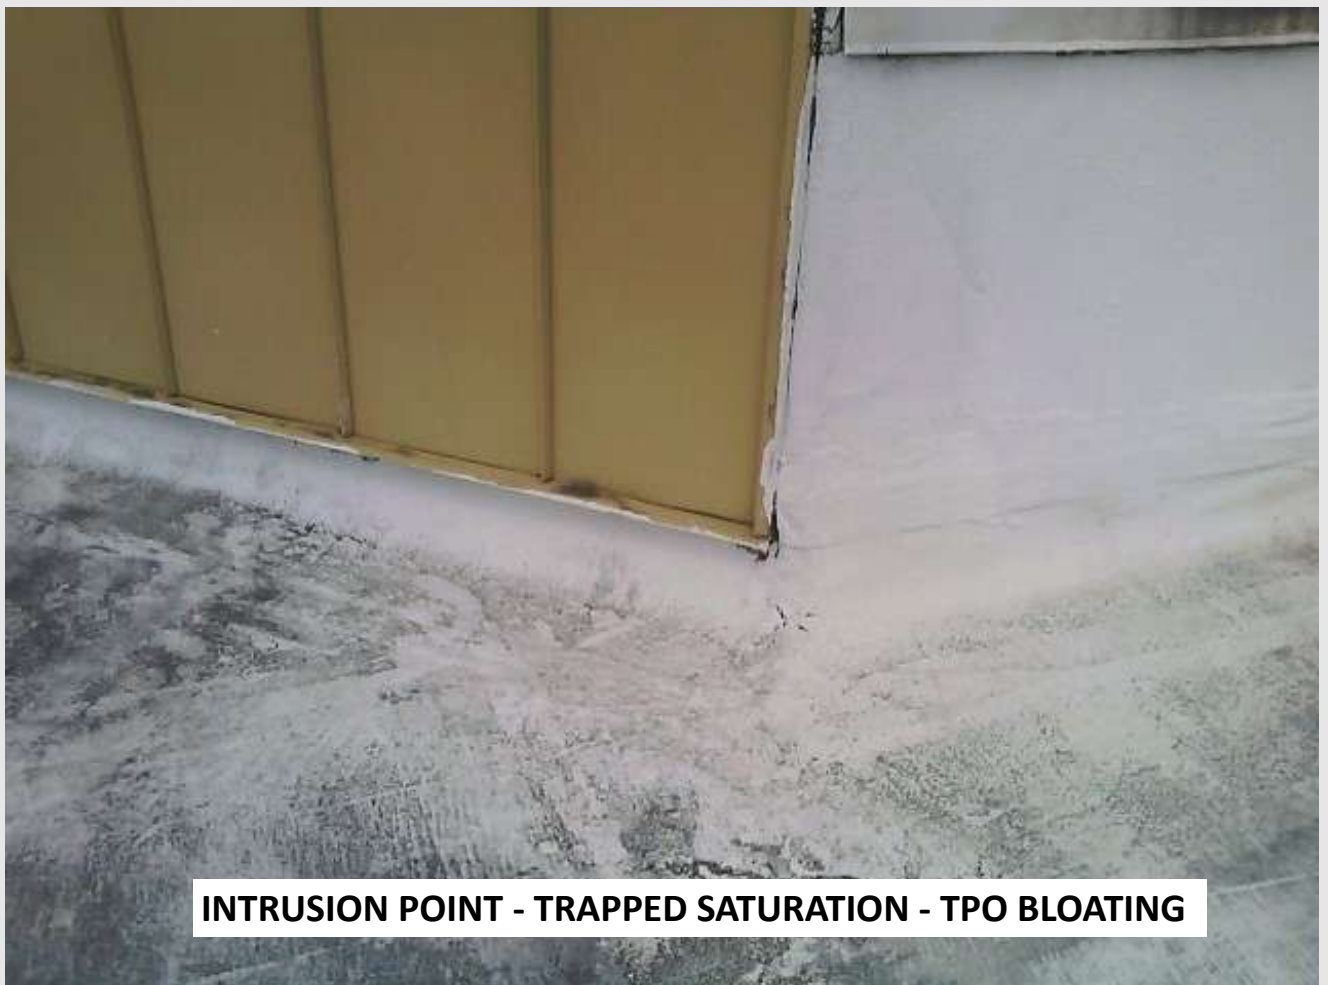
INTRUSION POINT - TRAPPED SATURATION - TPO BLOATING

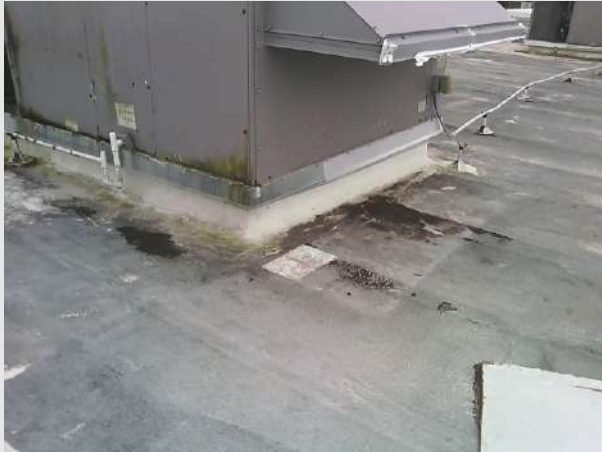
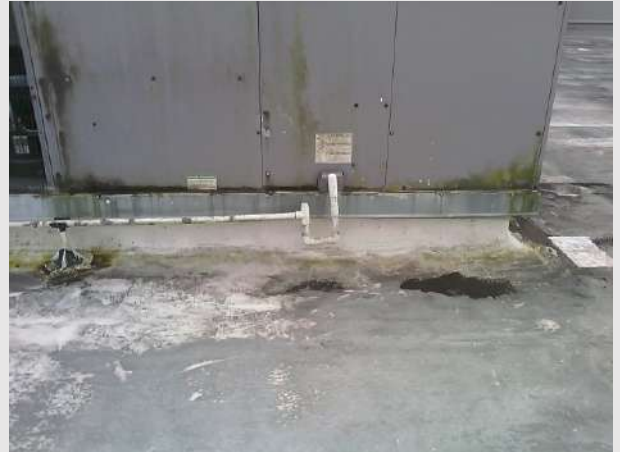
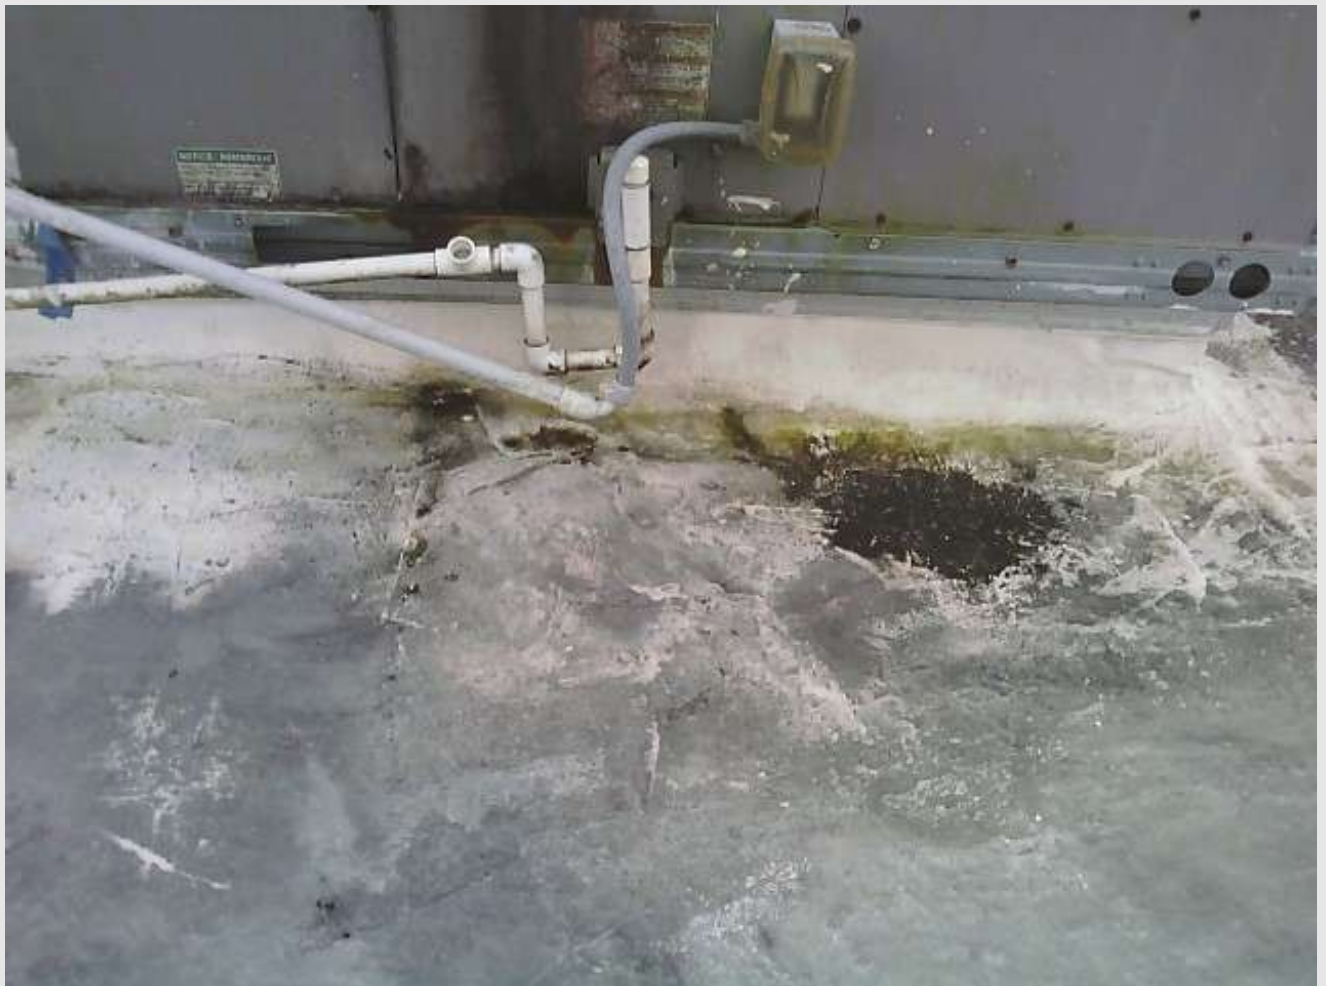
A/C SERIES IMAGING DOCUMENTING A/C FAILURE DRIVING DISCHARGE DIRECTLY UNDER TPO CREATING RUN THROUGH SEPERATING ADHESIVES AND MATERIAL CAUSING MATERIALS RELEASE AND BLOATED MEMBRANE

THROUGHOUT ROOF SURFACE REPAIR TECHNIQUE EXPOSED SUBSURFACE MATERIAL TO MOISTURE. THIS DANGEROUS SITUATION ADDS THOUSANDS OF POUNDS FROM MATERIAL SATURATION CHANGING WEIGHT DISTRIBUTION
