RESTORE REPORTS DOCUMENTATION

SKETCH/AREA TABLE ADDENDUM

*** INTRUSION FAILURES PLAGUE THIS PROPERTY - STRUCTURE HAS THESE AREAS NEED IMMEDIATE ATTENTION ALLOWING COMMON STRUCTURE CONTAINMENT SAVING INTERIOR COMPONENTS (A/C - APPLIANCES - PREVENTING MOLD GROWTH)***

POST INSPECTION CONCLUSION

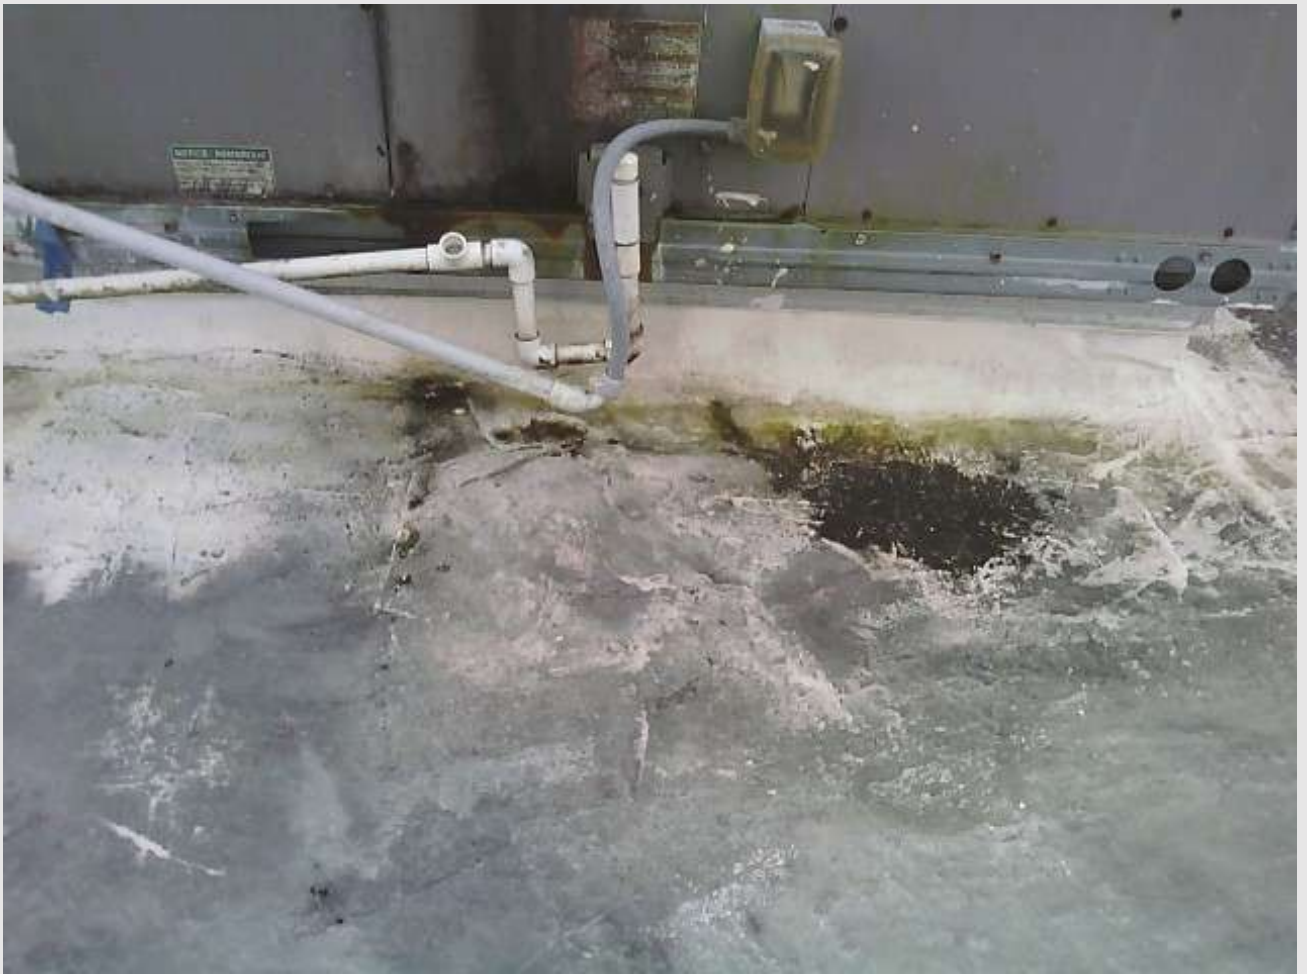
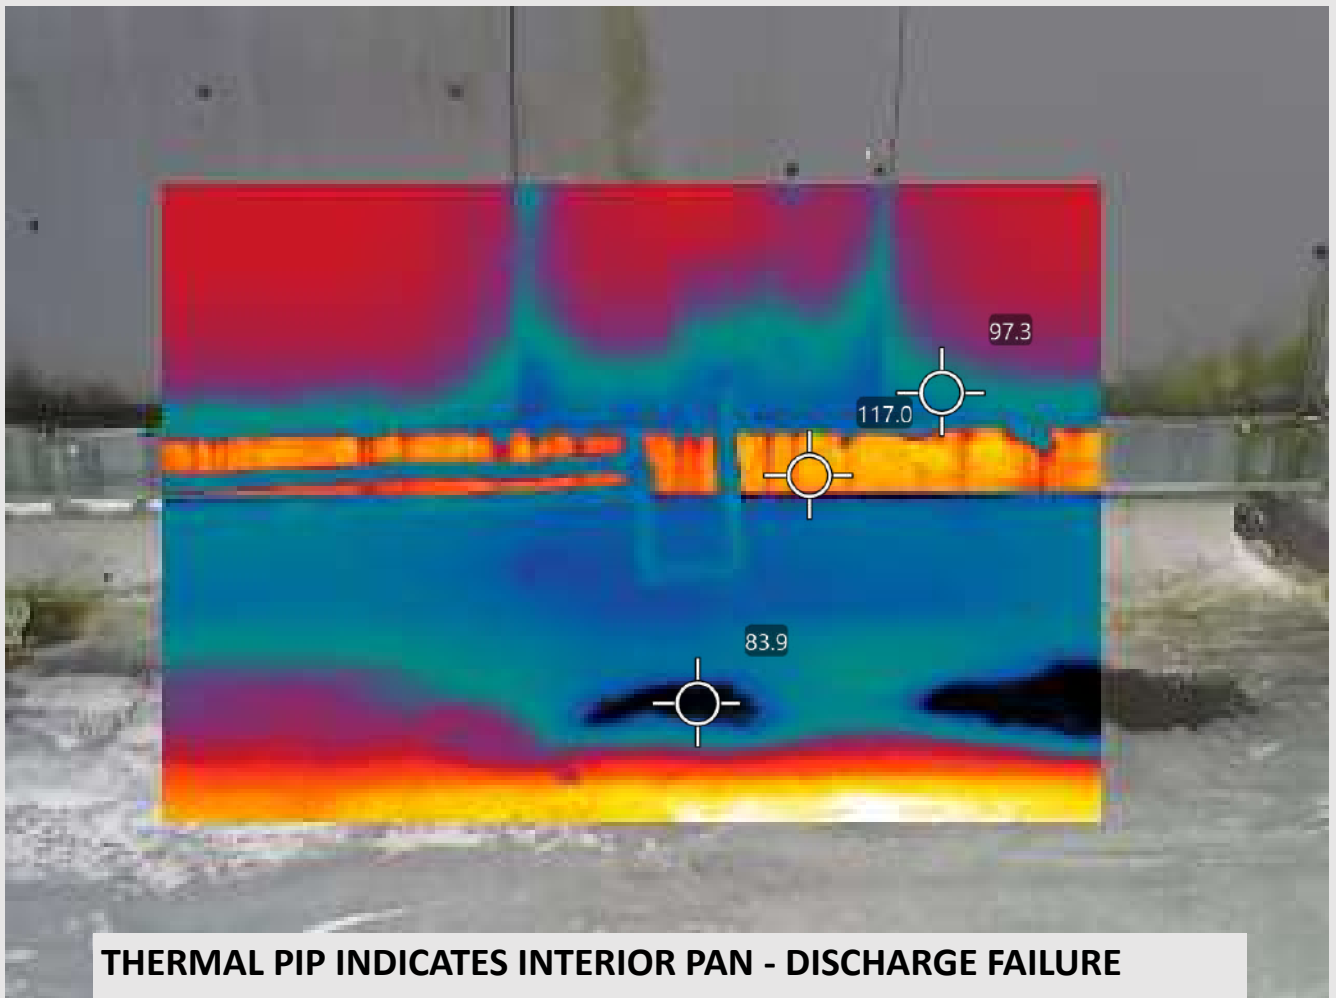
THERMAL PIP INDICATES INTERIOR PAN - DISCHARGE FAILURE SATURATING SUBSURFACE MATERIAL CREATING SEPERATION AND BLOATING FAILURE(S)

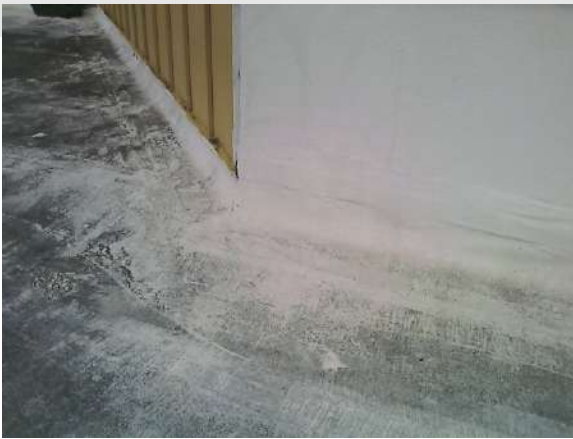
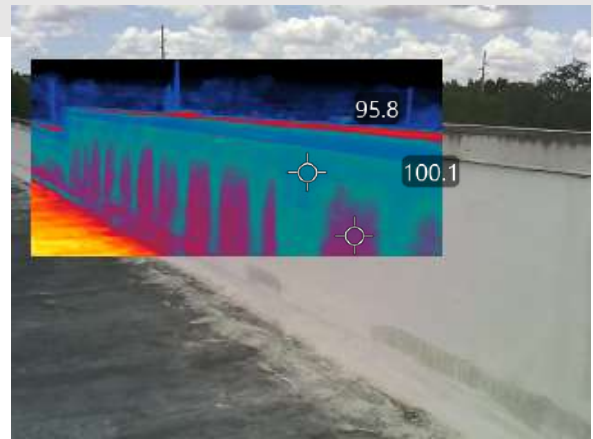
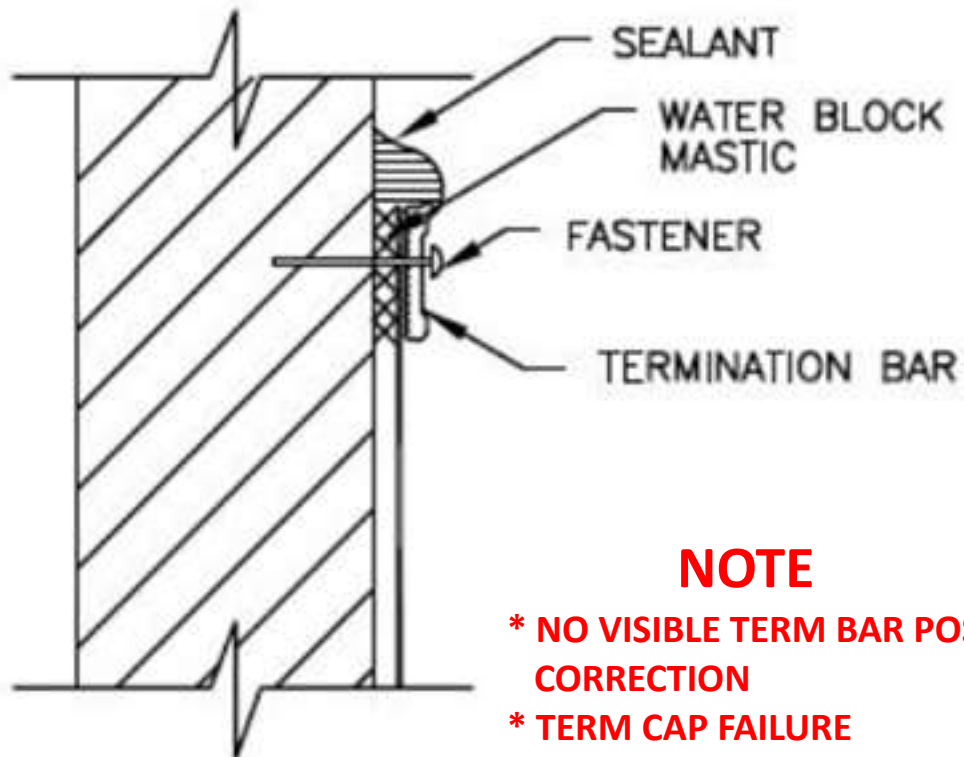
Figure 1 – Typical Term Bar Detail

EXAMPLE(S) OF SATURATION BENEATH MEMBRANE LEAKING INTO SUB - STRUCTURE CAUSING LEAK DIRECTLY IN BUILDING ENTRANCE.

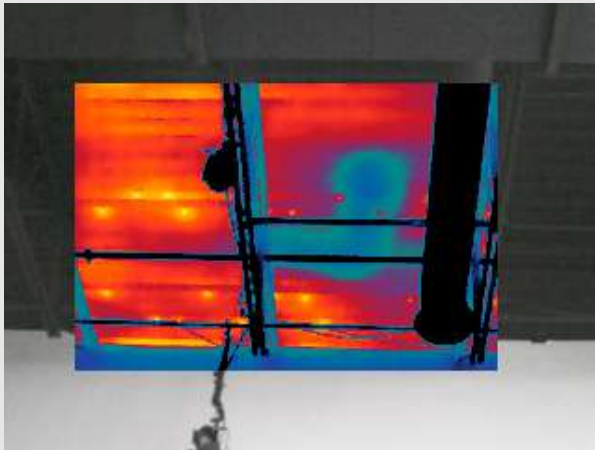
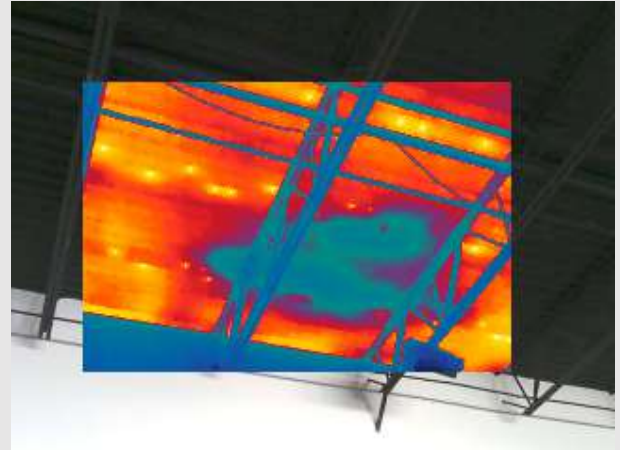
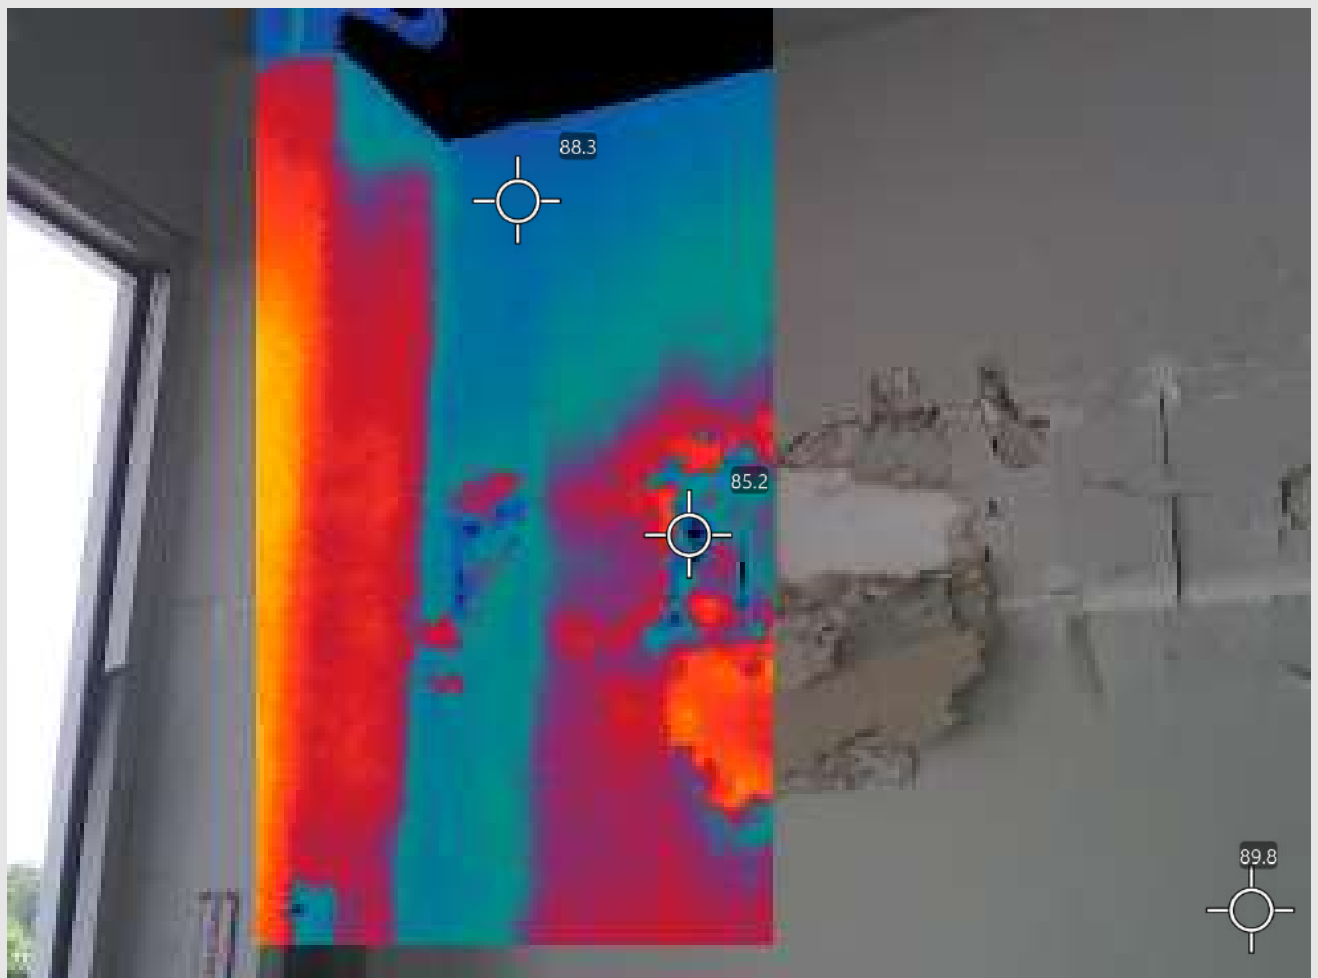
EXAMPLE(S) OF SATURATION BENEATH MEMBRANE LEAKING INTO SUB - STRUCTURE CAUSING LEAK DIRECTLY IN VACANT UNIT SEPERATE FROM CHURCH BUILDING

MEMBRANE ATTACHMENT IMAGING DOCUMENTING MATERIAL TERMINATION FAILURE DRIVING DISCHARGE DIRECTLY UNDER TPO CREATING RUN THROUGH SEPERATING ADHESIVES AND MATERIAL CAUSING MATERIALS RELEASE AND BLOATED MEMBRANE

THROUGHOUT ROOF SURFACE REPAIR TECHNIQUE EXPOSED SUBSURFACE MATERIAL TO MOISTURE. THIS DANGEROUS SITUATION ADDS THOUSANDS OF POUNDS FROM MATERIAL SATURATION CHANGING WEIGHT DISTRIBUTION

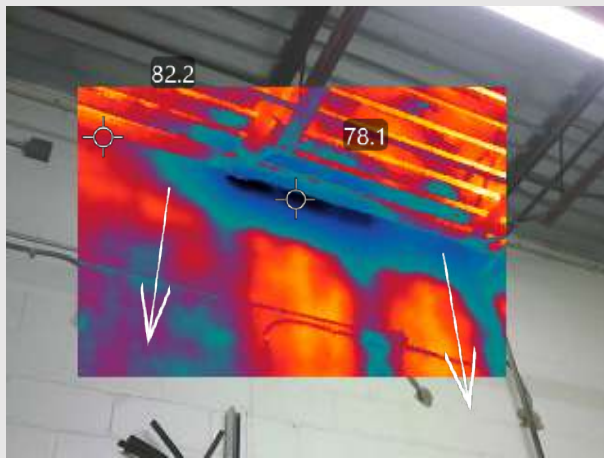
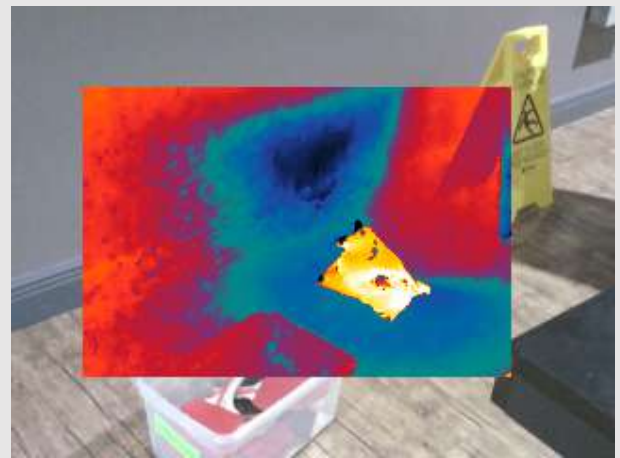
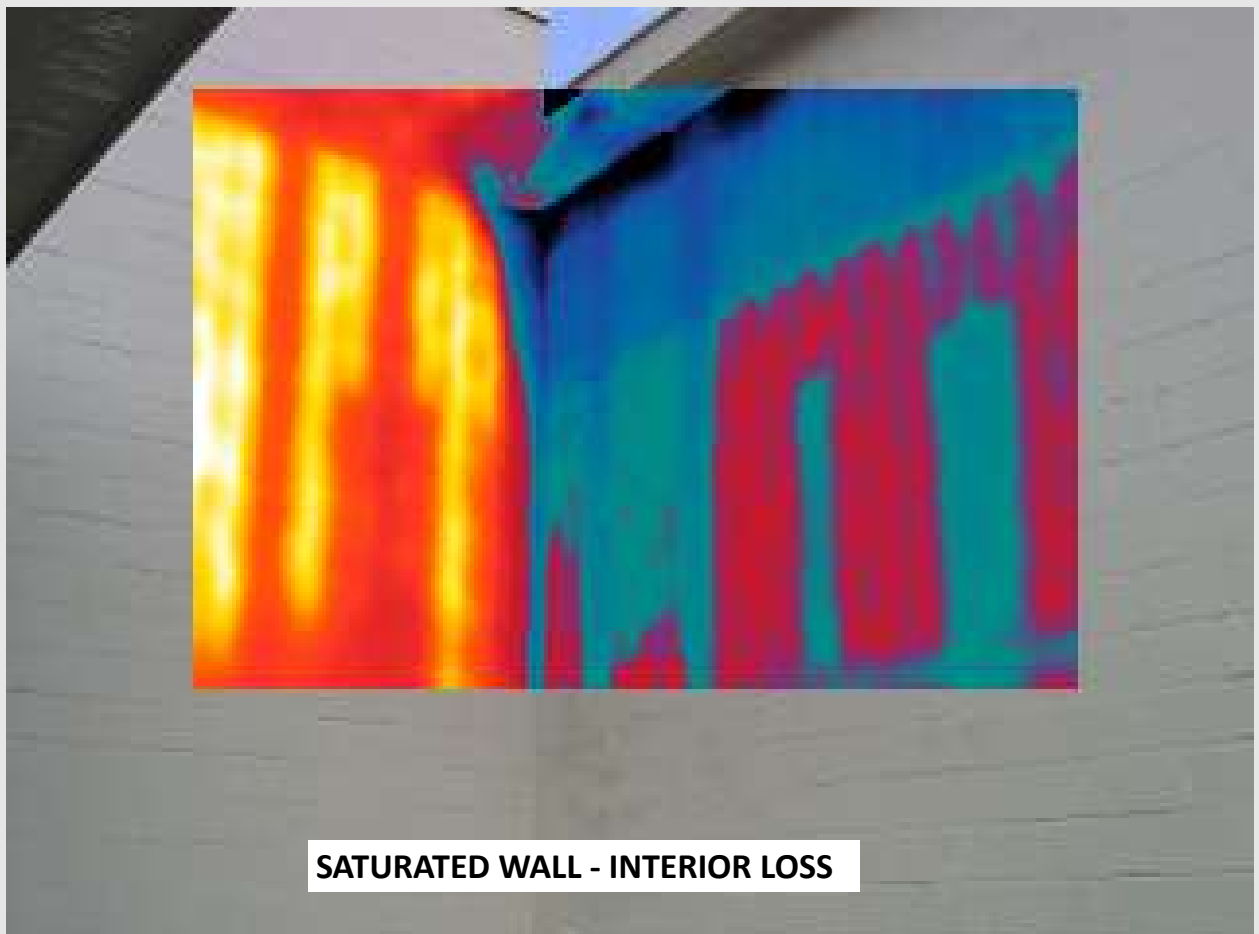
SATURATED WALL - INTERIOR LOSS

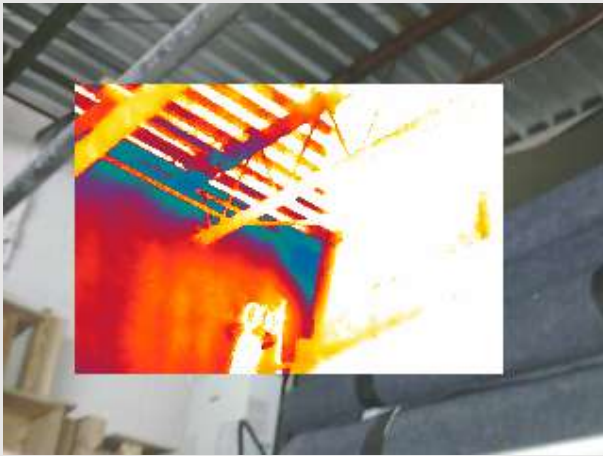
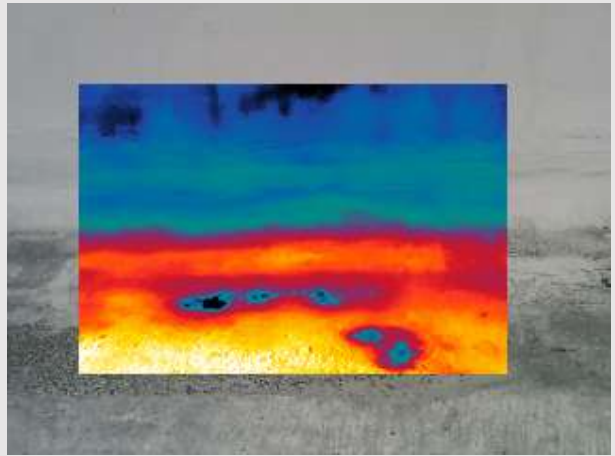
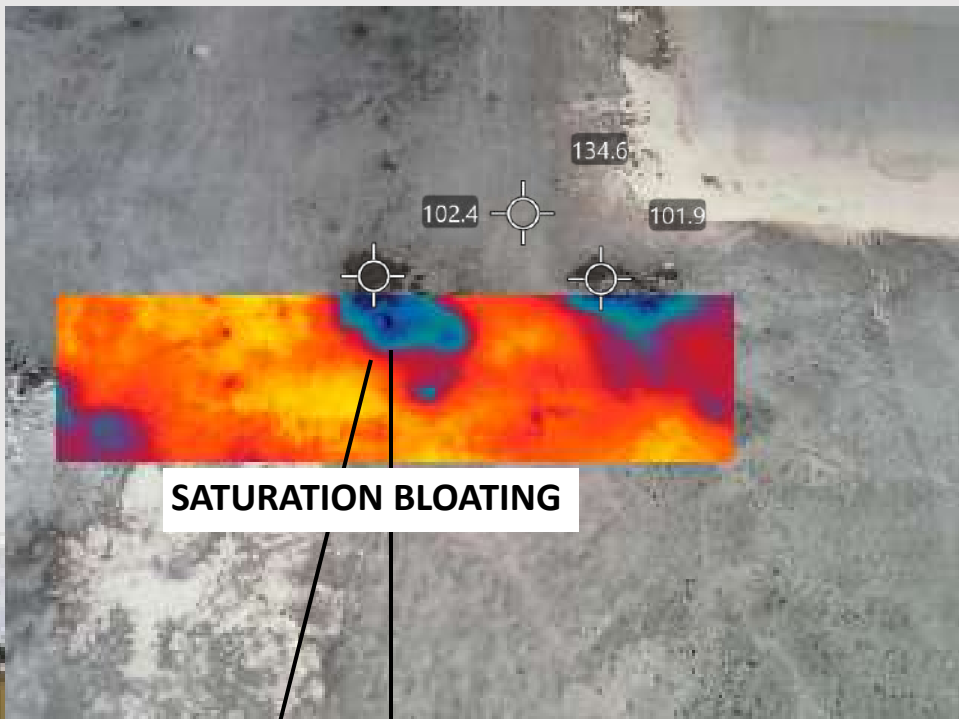
SATURATION BLOATING
