RESTORE REPORTS DOCUMENTATION

SKETCH/AREA TABLE ADDENDUM

*** INTRUSION FAILURES PLAGUE THIS PROPERTY - STRUCTURE HAS THESE AREAS NEED IMMEDIATE ATTENTION ALLOWING COMMON STRUCTURE CONTAINMENT SAVING INTERIOR COMPONENTS (A/C - APPLIANCES - PREVENTING MOLD GROWTH)***

POST INSPECTION CONCLUSION

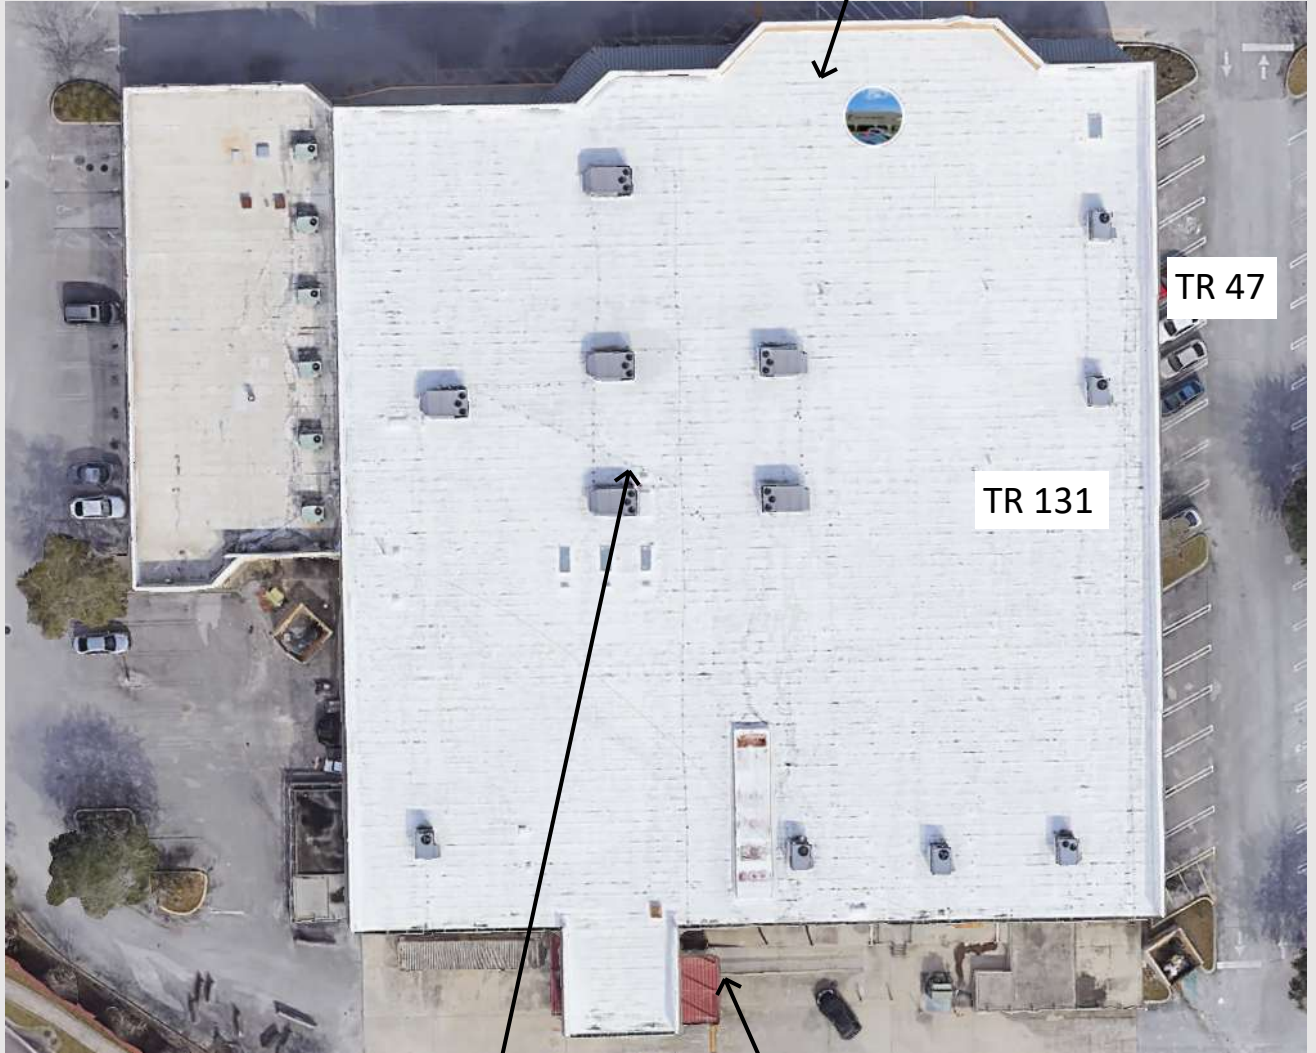
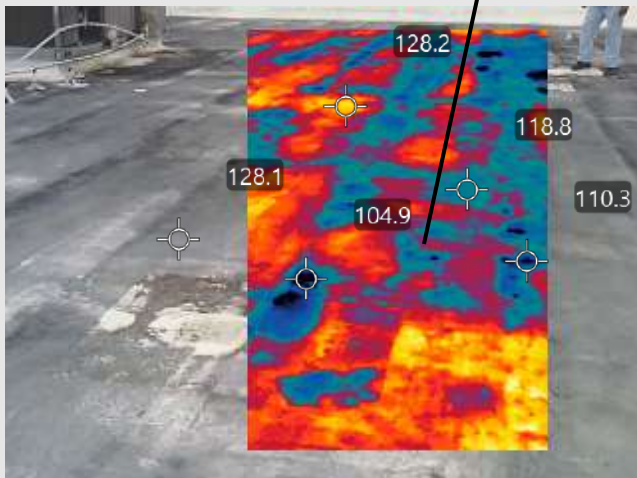
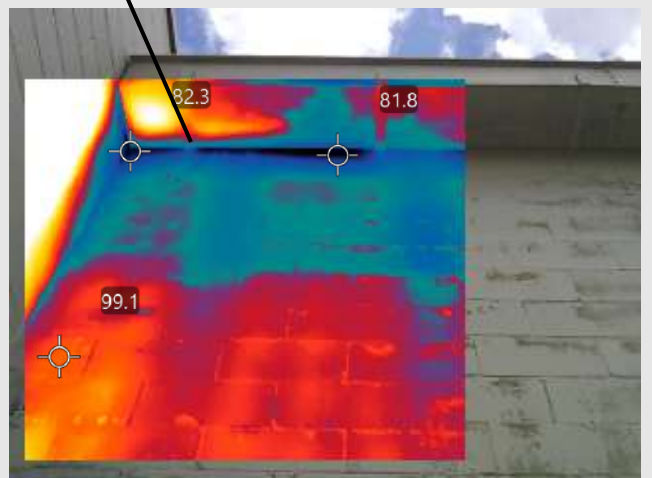
TR 131

CAP TERMINATION FAILURE ALLOWING SEPERATION. SATURATION INDICATED BENEATH MEMBRANE

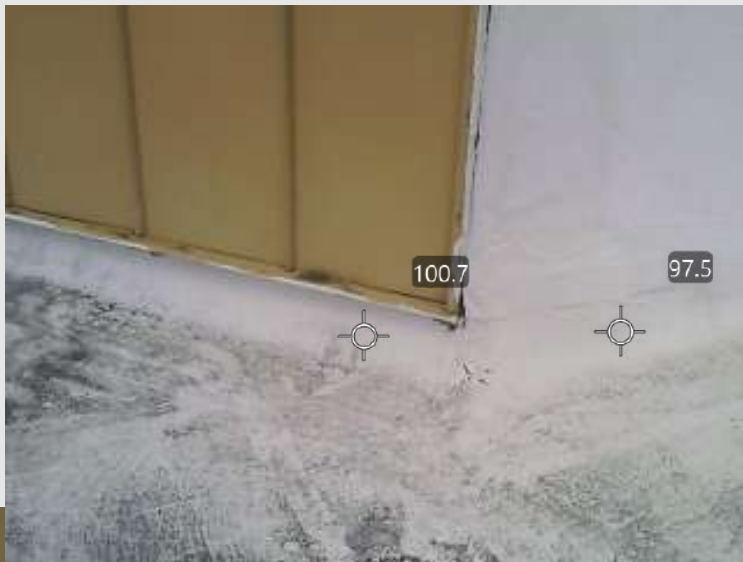
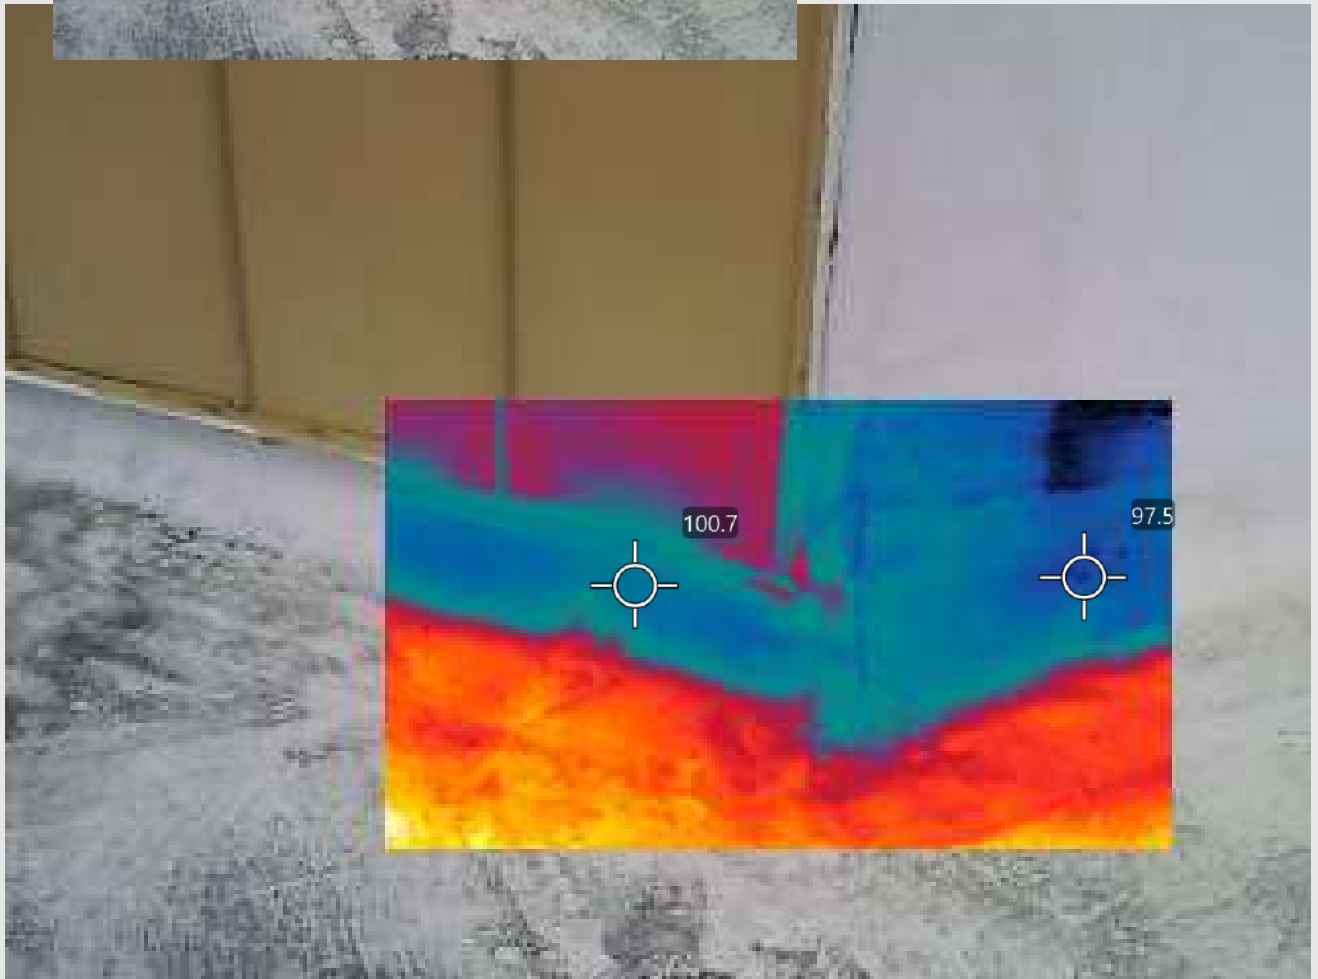
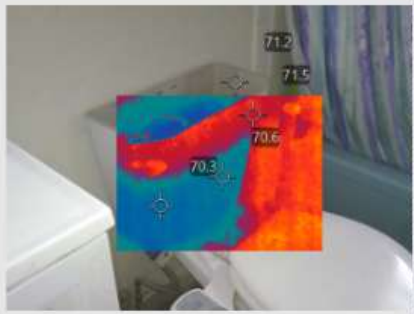
**MEMBRANE ATTACHMENT IMAGING DOCUMENTING MATERIAL
TERMINATION FAILURE DRIVING DISCHARGE DIRECTLY UNDER TPO CREATING
RUN THROUGH SEPERATING ADHESIVES AND MATERIAL CAUSING MATERIALS
RELEASE AND BLOATED MEMBRANE**

**THROUGHOUT ROOF SURFACE REPAIR TECHNIQUE EXPOSED SUB SURFACE
MATERIAL TO MOISTURE. THIS DANGEROUS SITUATION ADDS THOUSANDS
OF POUNDS FROM MATERIAL SATURATION CHANGING WEIGHT
DISTRIBUTION**

RADIOMETRIC THERMAL IMAGING INDICATION WILL REPRESENT TOTAL MATERIAL SATURATION IN **BLUE**

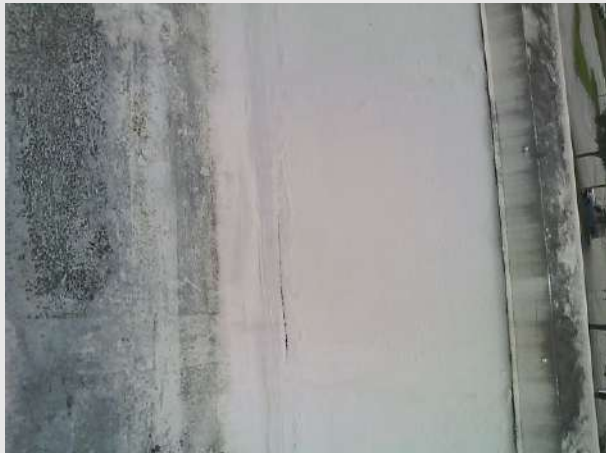
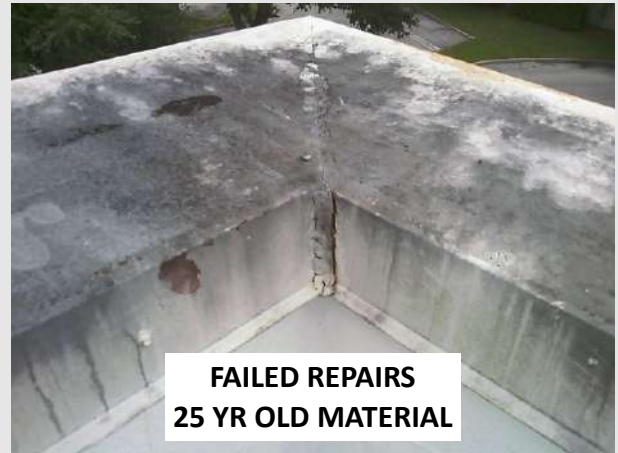
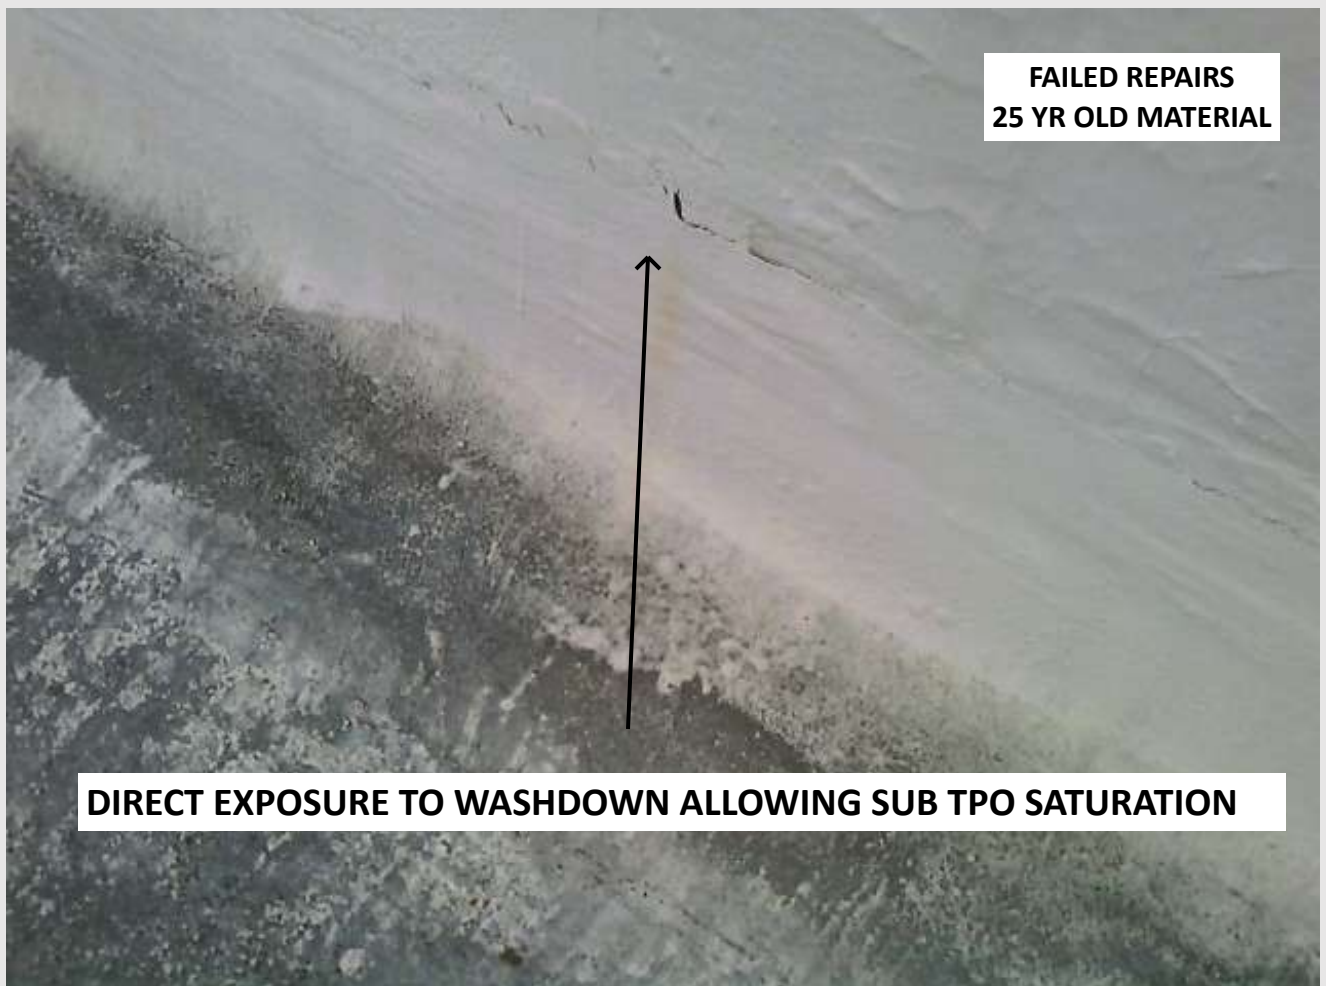
ORIGINAL METAL CAP FLASHING SHOWS STRESS FAILURE (CRACKING) AND SEAM FAILURE ALLOWING RAIN WATER TO PENETRATE BENEATH TPO MEMBRANE CREATING EXTERNAL BLISTERING OF MATERIAL. ONCE BENEATH MEMBRANE SATURATION OF MATERIALS AND LEAKING OCCUR. REVIEW OF ISSUED PERMITS DOESNT INCLUDE ROOF REPAIR OR REPLACEMENT.

THIS WOULD LEAD US TO BELIEVE THE MATERIALS IN INSPECTED ARE ORIGINAL TO BUILD (1998) MAKING THE ROOF 25 YRS OLD . ALL MATERIALS INCLUDED IN ROOF SYSTEM HAVE EXCEEDED MANUFACTURES' LISTED LIFE EXPECTANCY

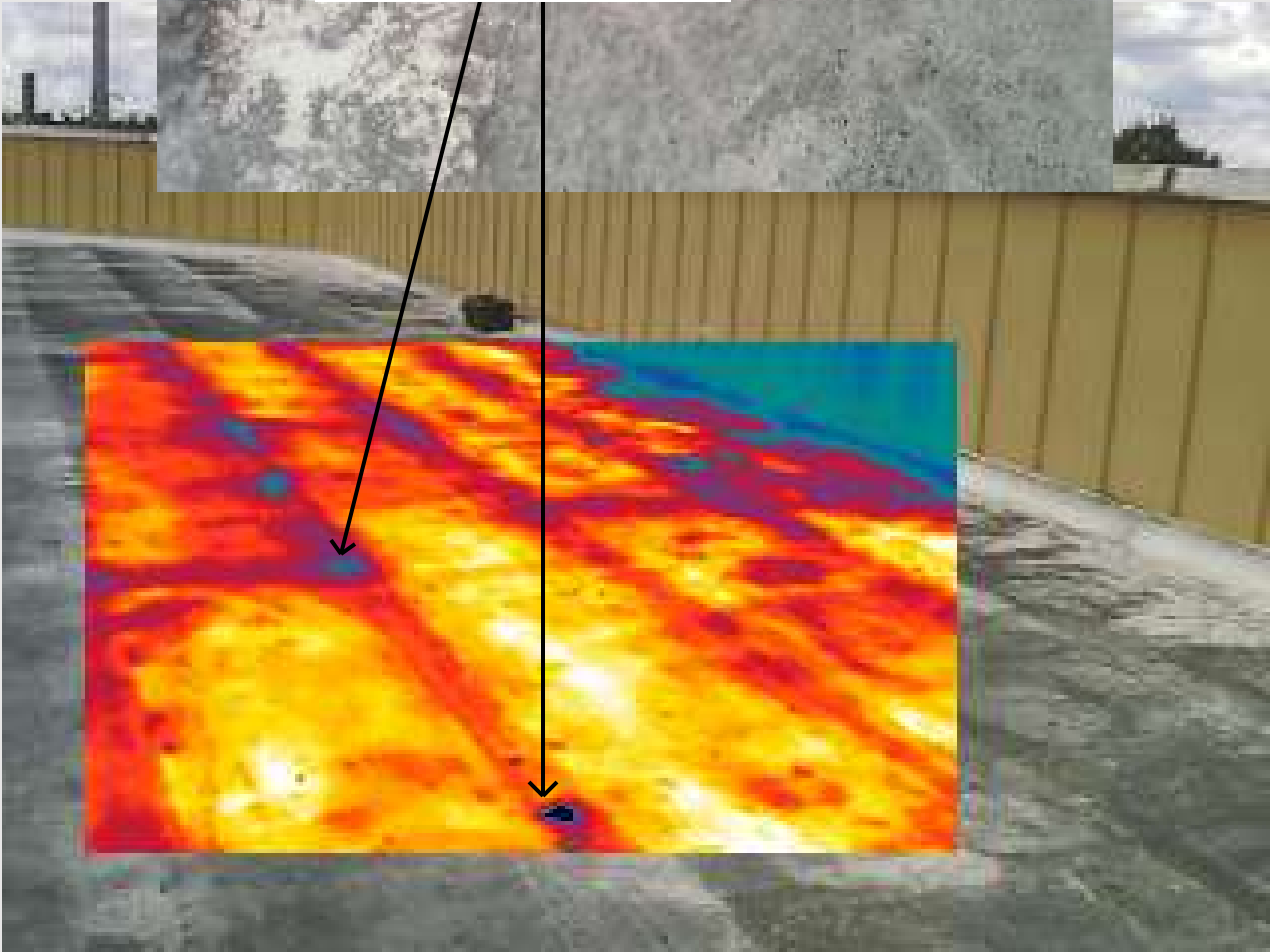
SATURATION BLOATING

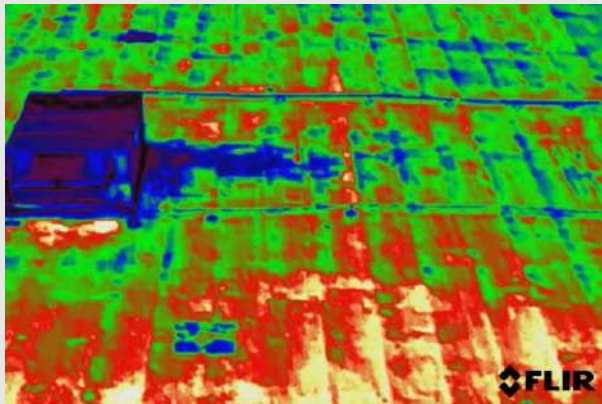
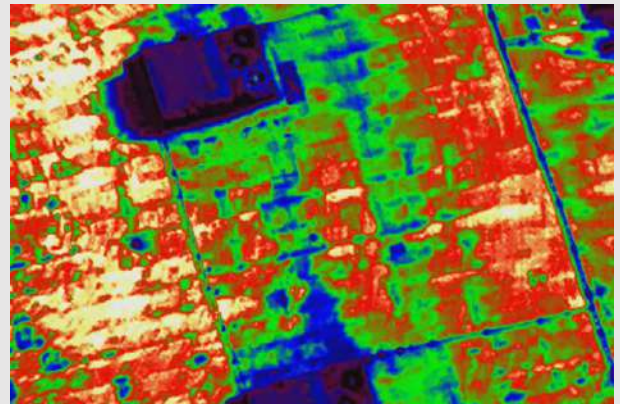
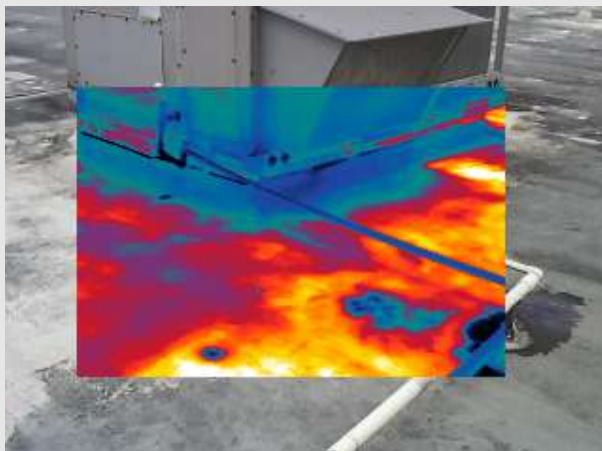
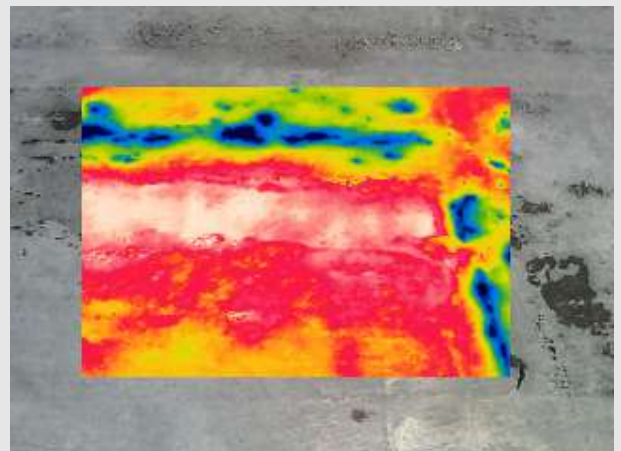
PROPERTY INSPECTION INCLUDED INTERIOR - EXTERIOR THERMAL PIP MAPPING - THERMAL DRONE LOSS MAPPING. INSPECTION REVEALED LARGE AREA(S) OF SATURATED DECKING MATERIAL CREATING SYSTEM AND COMPONENT FAILURE.

MATERIAL(S) FAILURES INCLUDE INSTALLATION AND REPAIR ISSUES NOTED IN REPORT. COMPONENTS AND MATERIAL(S) LIFESPAN MET NOT ALLOWING ANY SUGGESTED REPAIRS. THIS ROOF SYSTEM HAS MULTIPLE FAILURE(S) NOTES IN RESTORE REPORTS. THE BUILDING STRUCTURE HAS INTRUSION INTO SUBROOF INCLUDING LONGTERM DIRECT INTERIOR FAILURES CAUSING INTERIOR DRIPPING AND NOTED SATURATION RAISING INTERIOR HUMIDITY POSSIBLY COMPROMISING ELECTRICAL AND AV SYSTEMS. UNRESOLVED THESE CONDITIONS WILL SOON COMPROMISE A/C SYSTEMS MADE TO MAINTAIN AIR QUALITY IN SATURATED CONDITION. A/C MAINTNACE HAS BEEN NOT PROFESSIONALLY MAINTAINED ALLOWING A/C DICHARGE FAILURES DIRECTLY SATURATING ROOF SYSTEM

ALL ROOFING SYSTEMS COMPONENTS -

- 1) FAIL DUE TO AGE
- 2) NO ROOF SYSTEM MAINTNANCE
